REPORT OF THE OUTAGE REVIEW TEAM

*Appointed by the
Office of Utilities Regulation*

**TO INVESTIGATE THE
ELECTRICITY SYSTEM TOTAL
SHUTDOWN ON 2016 AUGUST 27**

2017 May 4

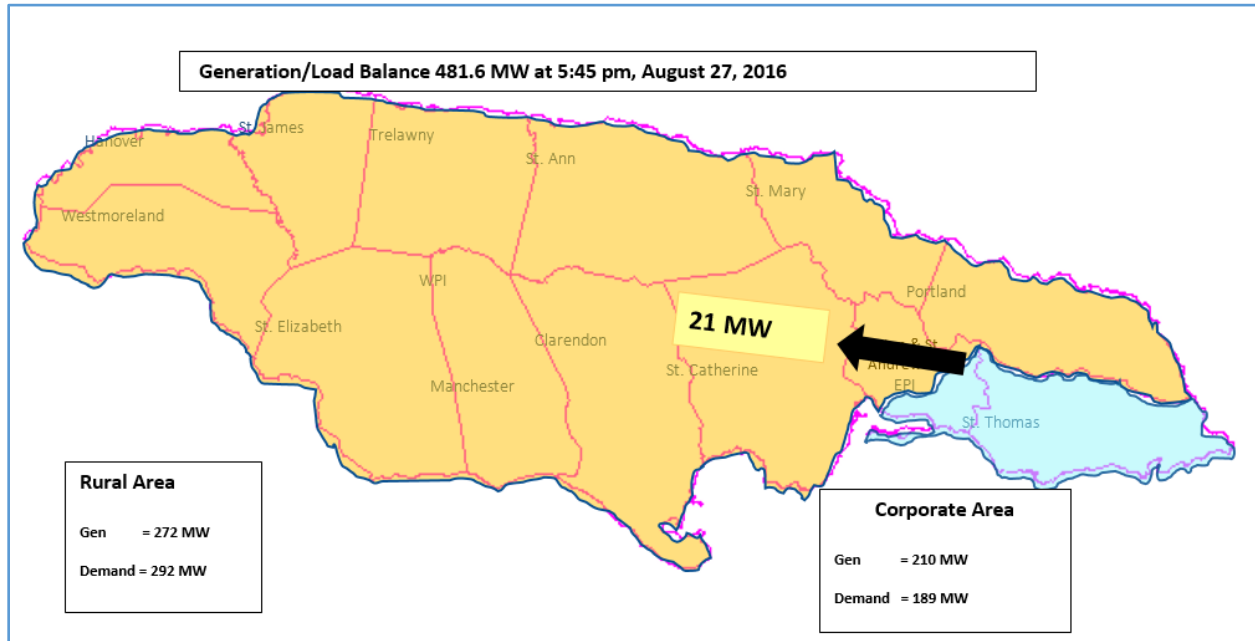
Figure 3.2: Generation/Load Balance at 5:45 pm, August 27, 2016

The generation/load balance at 5:45 pm, 2016 August 27, 2016 is illustrated in Figure 3.2 below.

Based on the available generation capacity online relative to the System demand just before the incident, the spinning reserve margin was **25.07 MW**. This was a clear violation of the spinning reserve requirements stipulated by the Spinning Reserve Policy set out under Schedule D of and the Generation Code (2013), applicable at the time (Refer to Figure 3.3 below). Subject to these requirements, JPS is required to plan and operate the System with a minimum spinning reserve capacity of 30 MW to meet the daily System demand.

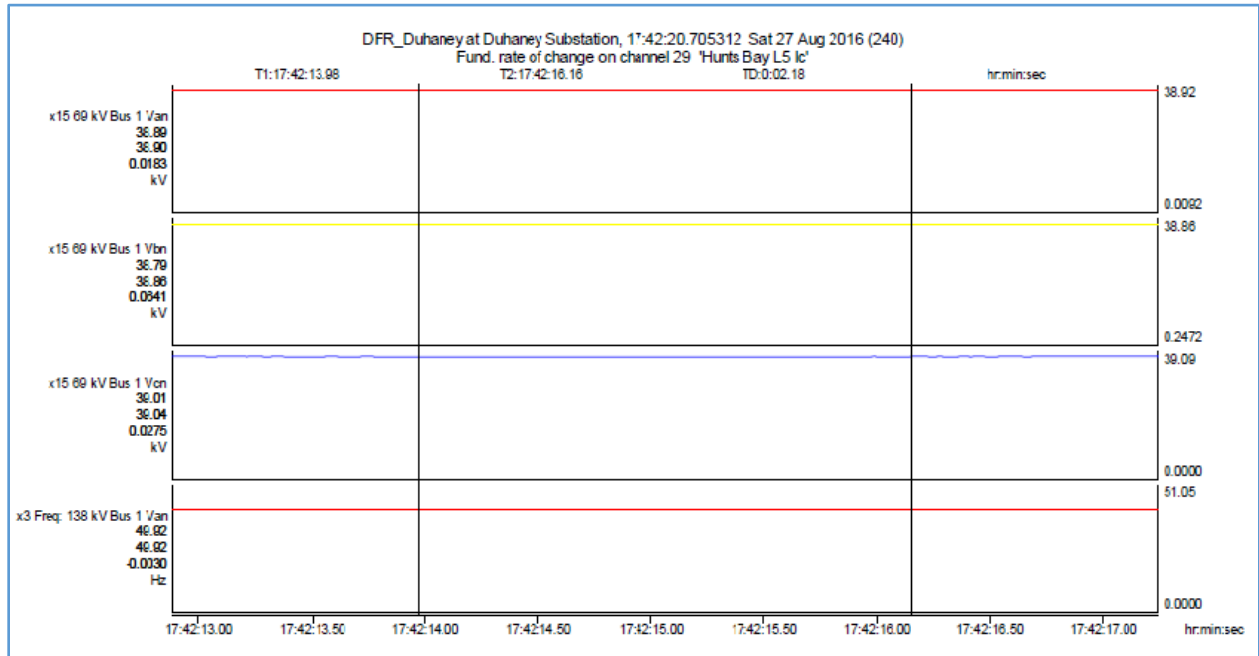
Figure 3.4: System Voltage and Frequency on August 27 up to 5:45 pm

On 2016 August 27 up to 5:45 pm, the System frequency recorded by Digital Fault Recorder (DFR) located at JPS' Duhaney substation was 49.92 Hz (Refer to Figure 3.4). This frequency level was within the normal operating range of 50.0 Hz \pm 0.2 Hz as specified by the Generation Code. As such, System frequency variation did not create any undue adverse conditions at the commencement of the power blackout. However, once the cascading events were initiated, the resulting large and uncontrollable variations in System frequency that ensued, compounded the situation, consequently leading to the total collapse of the System.

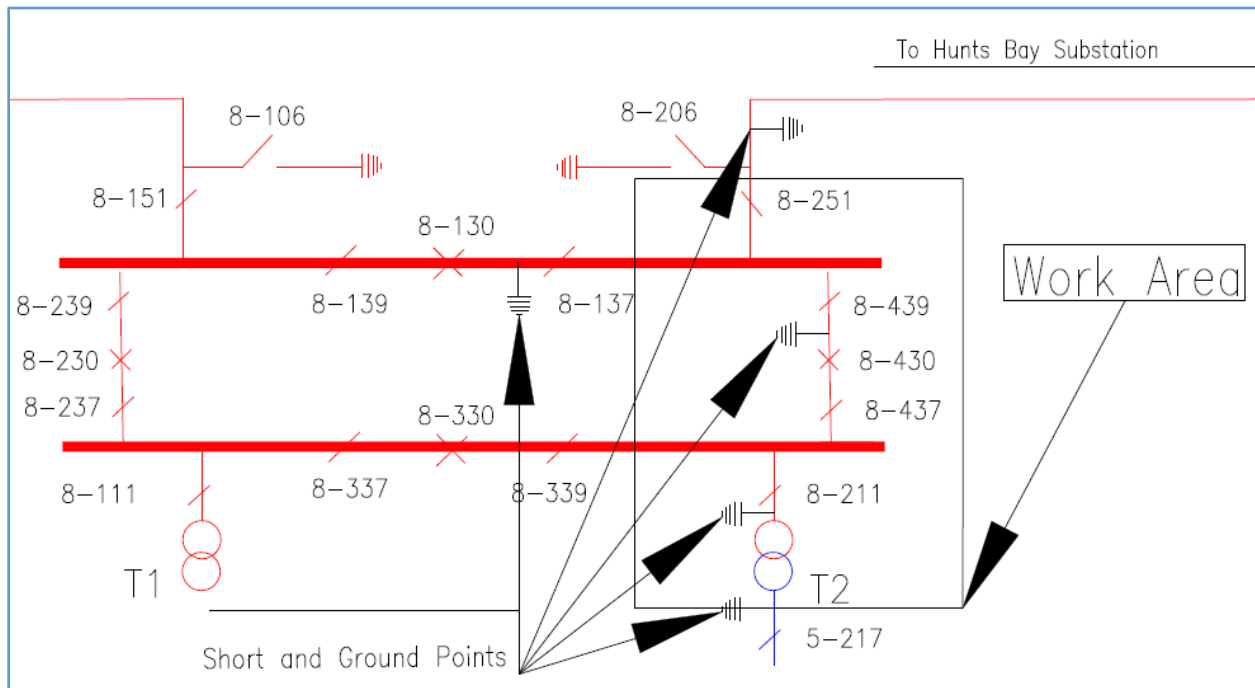
Figure 4.1: Work Area at PAJ Substation with location of “short-and-grounds”

The placement of the five (5) “short-and-grounds” by the JPS maintenance personnel is demonstrated in Figure 4.1 below.

JPS’ safety and switching procedures as well as prudent utility practice would dictate that the five “short-and-grounds” installed should be fully removed following completion of the maintenance and the cancellation of the LOTO PTW.

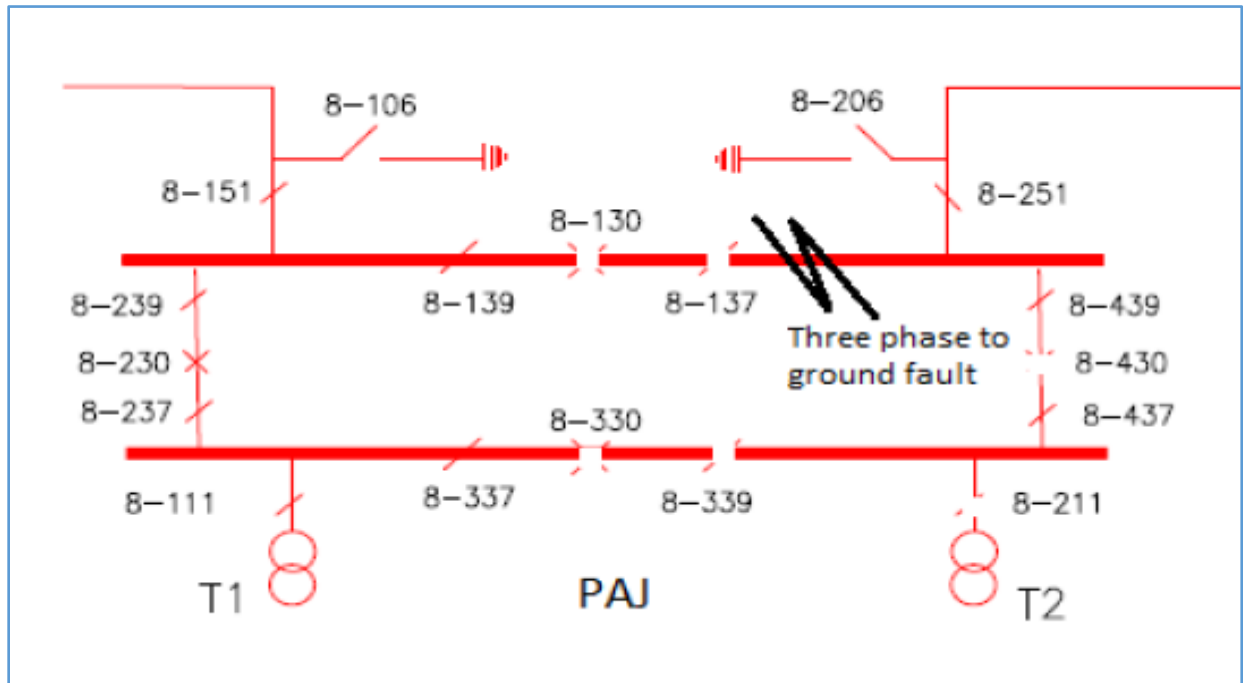
Figure 4.2: Illustration of the Fault at the PAJ Substation

At 5:45 pm clearance was given to the System Controller by the field supervisor to re-energize the Hunts Bay – PAJ 69 kV line and return the System to normal operation. At the instant of re-energizing the line, the System experienced a solid three phase-to-ground fault, which was found to be caused by the fact that “short-and-ground” (#1), one of the five “short-and-grounds” installed as a safety measure to facilitate the maintenance work at the PAJ substation, was left in place in the vicinity of breaker 169/8-130. An illustration of the three phase-to-ground fault is shown in Figure 4.2 below.

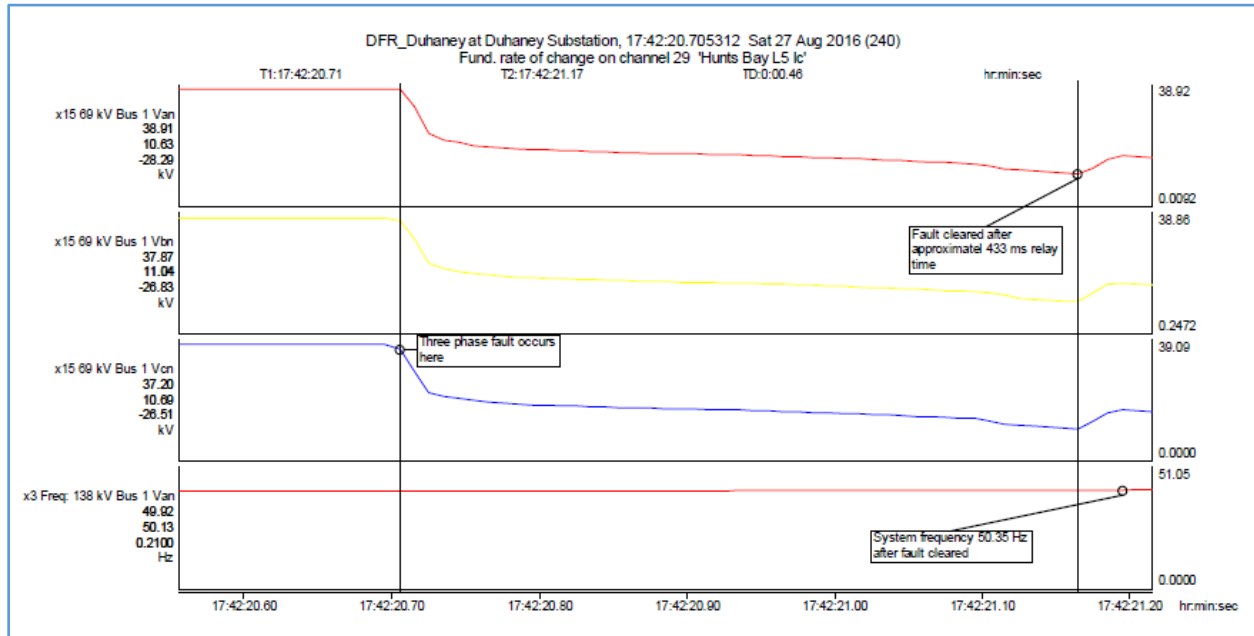
Figure 5.2: JPS Duhaney DFR Disturbance Record Showing Fault Duration

Category	Scheme	Design Time (ms)	Performance Status	Comments
Primary	SOTF – incorporated primary “A” distance relay	100	Failed	Defective Control Cable
First line Back-up	Directional Overcurrent	250	Failed	Defective Relays
Second Back-up	Zone 2 Distance Protection	433	Operated

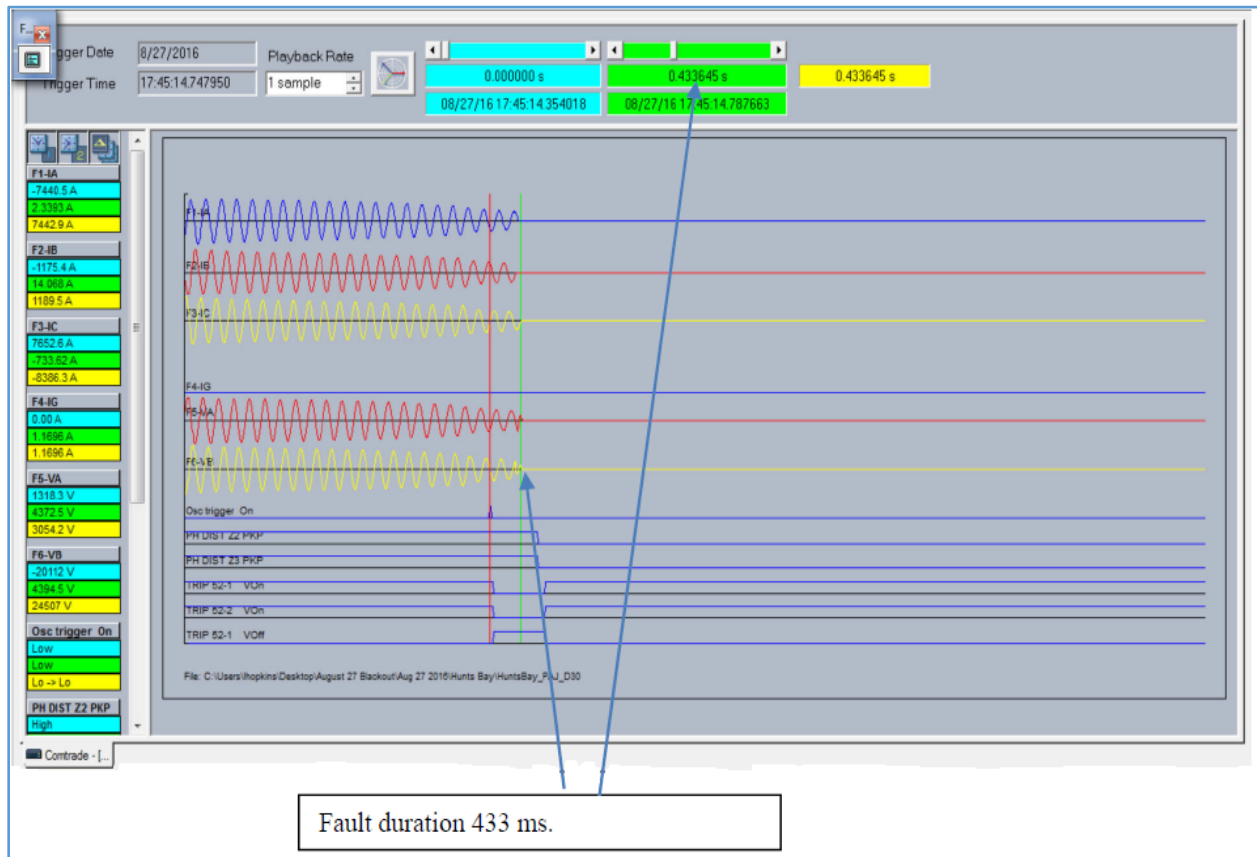
Figure 5.3: Hunts Bay-PAJ Primary “B” Zone 2 Distance Protection Fault Inception and Clearance

According to JPS, the time difference anomaly with the fault clearing time of 433 ms derived from the primary “B” trace shown in Figure 5.3 below is due to the fact that the primary “A” relay recorded two traces for the event with separate time stamps. JPS stated that when the time difference was calculated and the additional 3.5 cycles (70 ms) added, the cumulative time was 483 ms. On that basis, JPS affirmed that the fault clearing time of 433 ms as indicated by the DFR and primary “B” relay will be considered the official fault clearing time.

JPS’ declaration of the official fault clearing time appeared to have been partly substantiated by its Duhaney DFR disturbance records of the incident (section 5.2 of the “Technical Report”), particularly, the DFR response and line protection responses at Hunts Bay (PAJ line) including the plot (graph) shown in Figure 5.2 above. However, the information provided, does not clearly show how the fault duration was derived from those records.

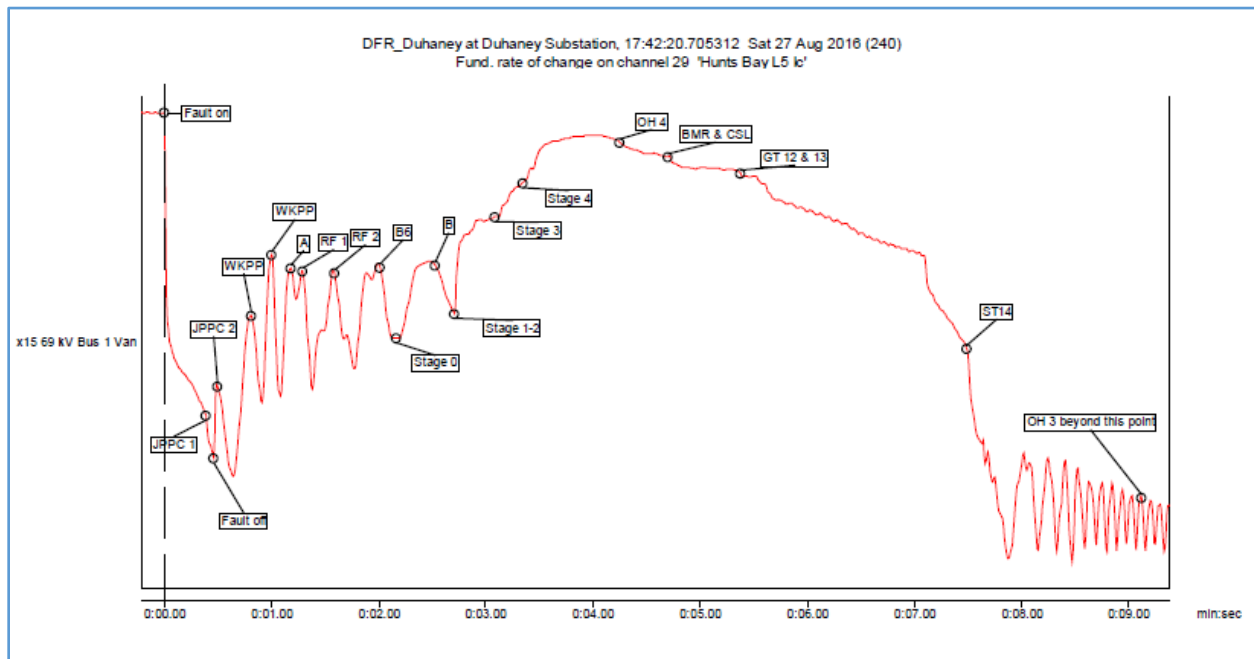
Figure 5.4: Duhaney DFR Disturbance Voltage Record with Generating Units Trips

The trip sequence of generating units on the System and voltage response is illustrated in Figure 5.4.

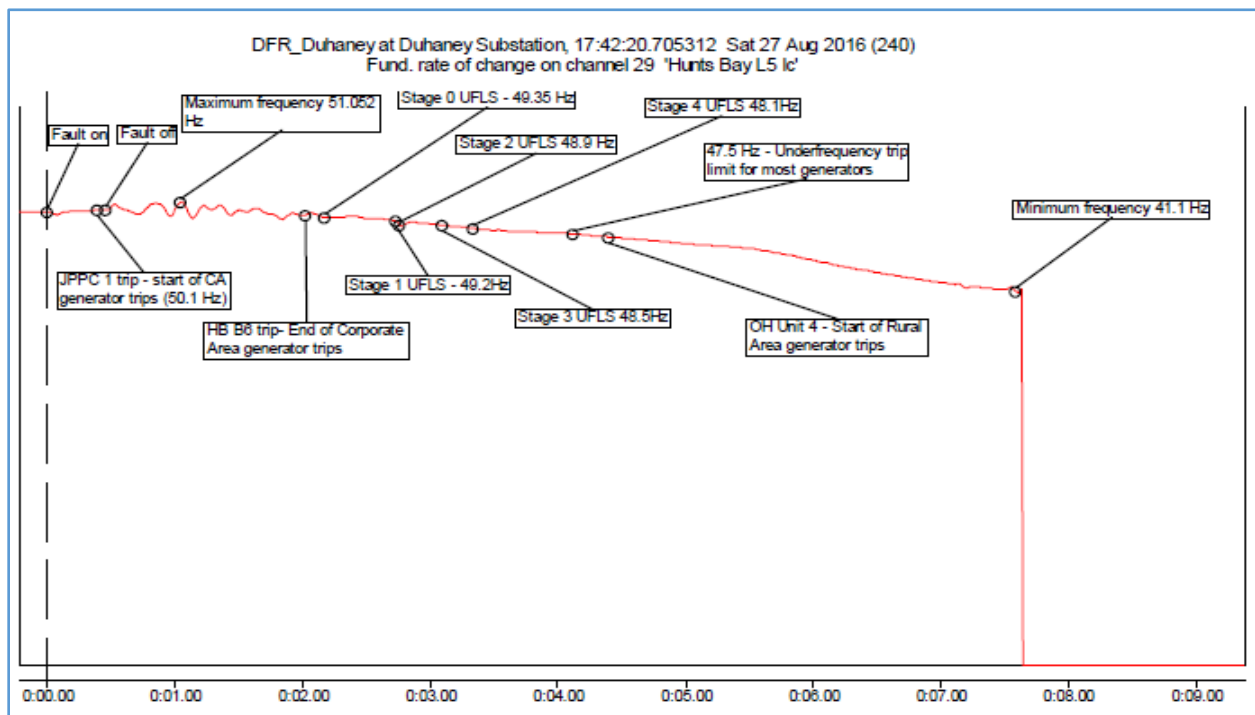
Figure 5.5: DFR Trace of Frequency Response and UFLS Relay Operation

The frequency response and operation of the automatic UFLS scheme is shown in Figure 5.5.
