REPORT ON INVESTIGATION OF JAMAICA PUBLIC SERVICE COMPANY LIMITED MAJOR SYSTEM FAILURE POWER SYSTEM ISLANDING AND WIDESPREAD OUTAGE 2016 APRIL 17 at 6:59 p.m.

DOCUMENT TITLE AND APPROVAL PAGE		
1. DOCUMENT NUMBER:		
2. DOCUMENT TITLE: Report on Investigation of Jamaica Public Service Company Limited Major System Failure, Power System Islanding and Widespread Outage 2016 April 17 at 6:59 p.m.

2016 April 17 JPS System Outage Analysis

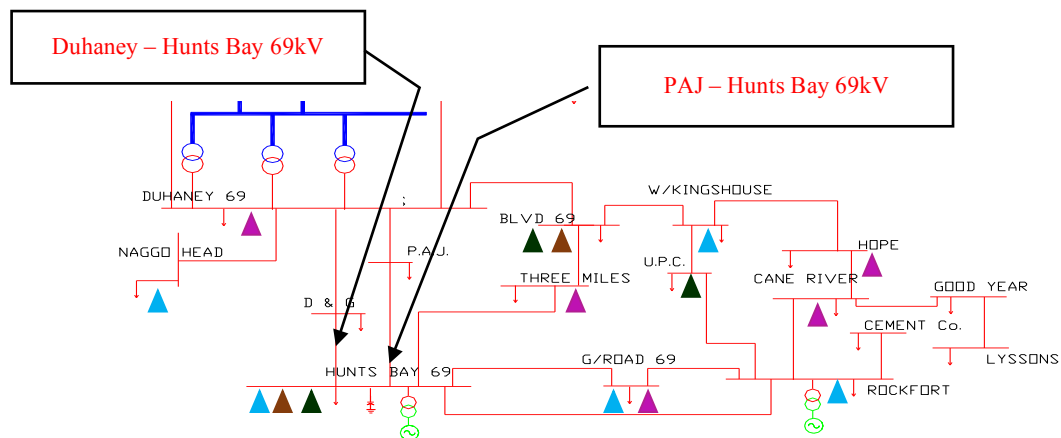
Figure 6: Corporate area 69 kV Transmission Network

Figure 6 shows the electrical single line configuration of the corporate area 69 kV transmission network and highlights the Duhaney – Hunts Bay and the PAJ – Hunts Bay lines.

The lines were planned to be taken out of service between 7:00 am to 6:00 pm for pole relocation work. No other transmission outages were planned for the day. However, the line outages were delayed and did not start until 10:55 am when the permit to work was issued.

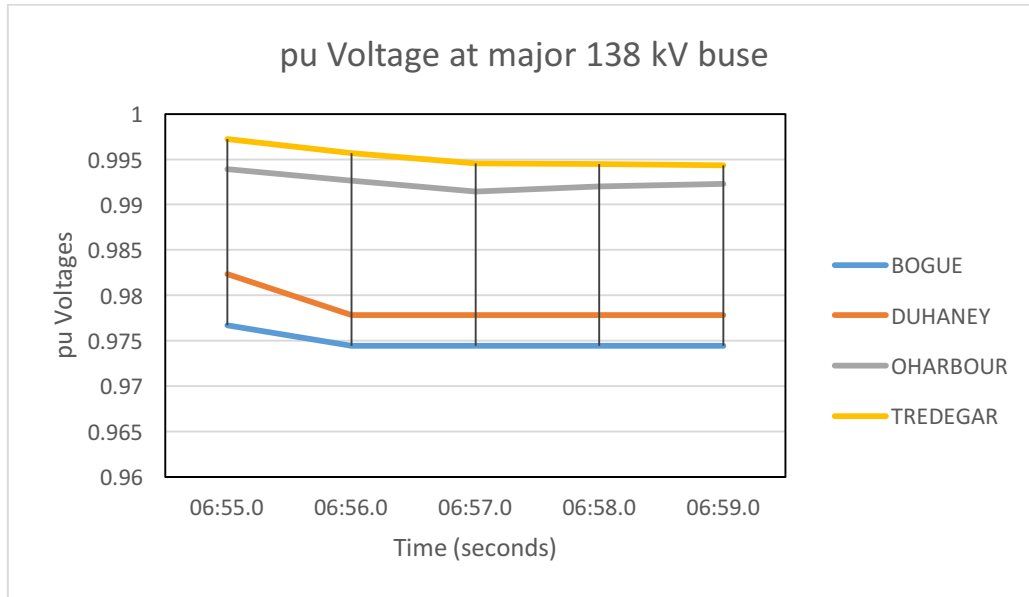
Figure 7: 138 kV substation bus voltage profile on April 17, 2016 at 6:59 pm

The slight reduction in voltage is due to the increasing load level over the duration. The generation power factor was 0.97 which would indicate that there were no requirement for additional reactive power support. System real power demand was 579.4 MW and reactive power requirement was 151.6 MVar.

It can be concluded that voltage levels were not violated and voltage stability was not an issue prior to the outage and did not contribute to initiating the system outage.

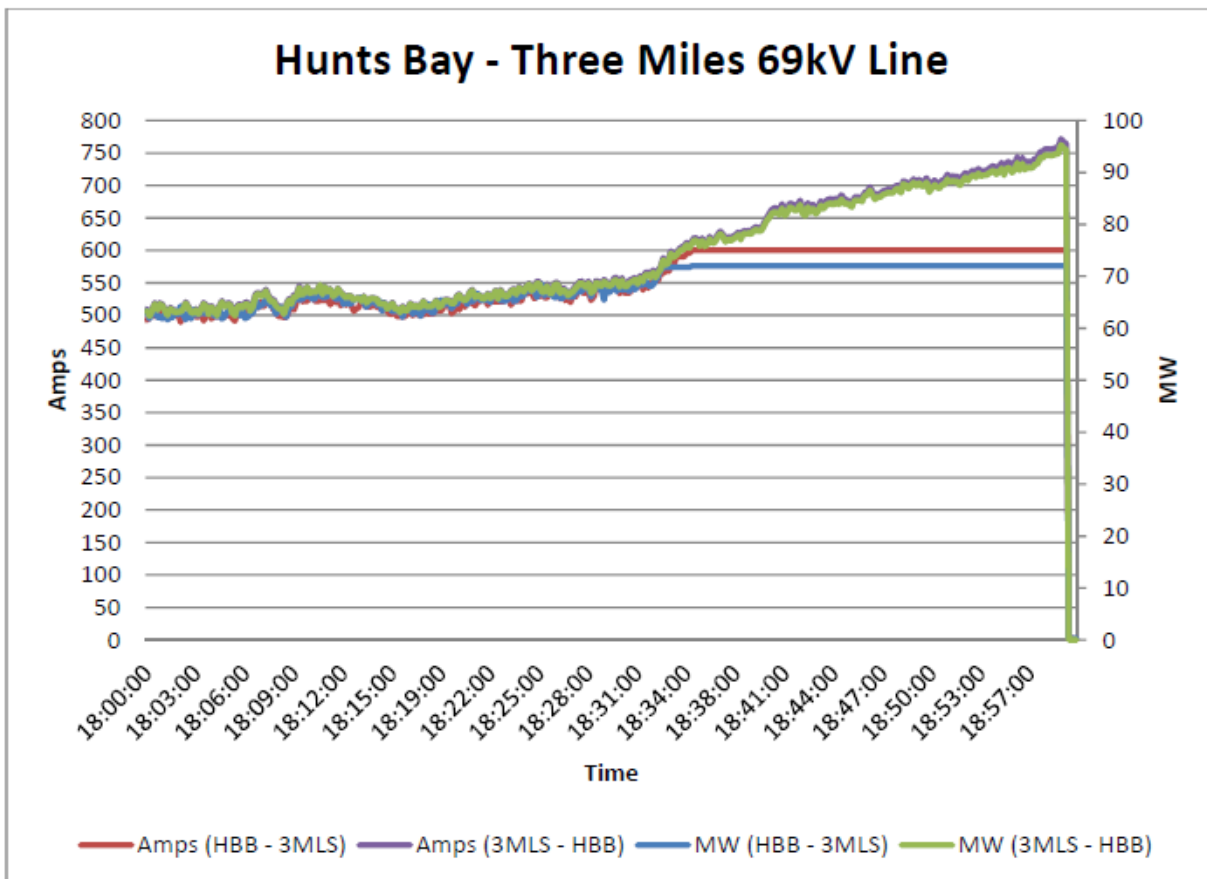
Figure 9 Power flow data on Hunts Bay – Three Miles 69kV line using SCADA

OPEN DDC – PLAYBACK FRAME RATE = 3S/FRAME					
		SYSTEM LOAD	HB/3MILES LINE		
FRAME #	TIME	(MW)	AMPS	% LOADING	NOTES
0	18:30:00	511	545	102.4	CALL RETURNED FROM LOGAN AT 6:25PM
100	18:33:00	520	570	107.1	
150	18:34:00	524	595	111.8	
165	18:35:00	526.5	600	112.8	
375	18:43:00	543.7	600	112.8	AMP VALUE NOT INCREASING
850	18:58:18	575	600	112.8	
883	18:59:24	579.2	600	112.8	
884	18:59:30	579.2	600	112.8	SEPARATION TIME
912	19:00:00		600	112.8	OH3 TRP

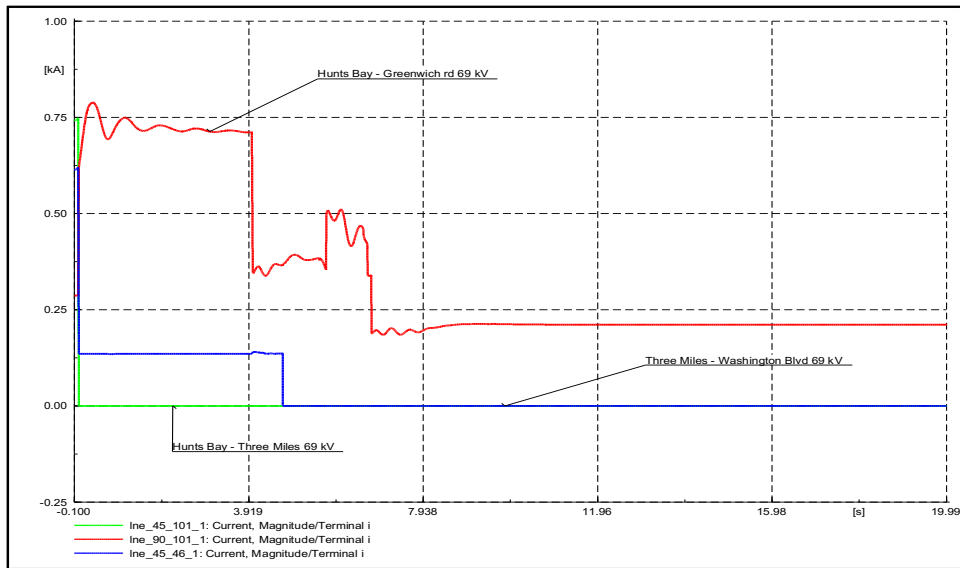
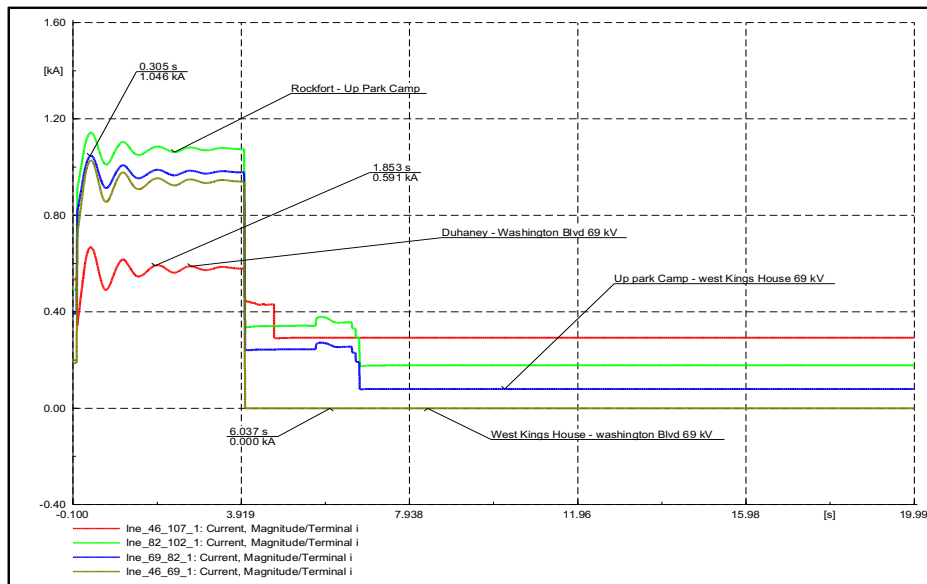
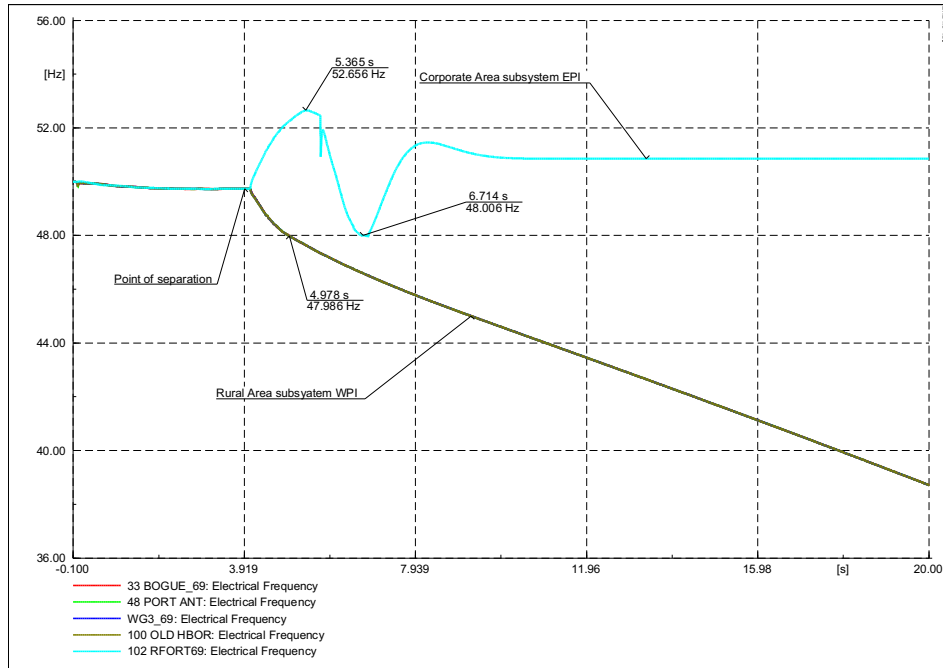
Case 2: Hunts Bay – Three Miles and West Kings House Rd. 69 kV lines tripped.

This case simulated the system conditions as it occurred on 2016 April 17 at 6:59 pm
