Office of Utilities Regulation

**Enquiry into JPS Power System
Shutdown of July 15, 2006**

Final Report

DOCUMENT NUMBER: Ele 2006/04.1

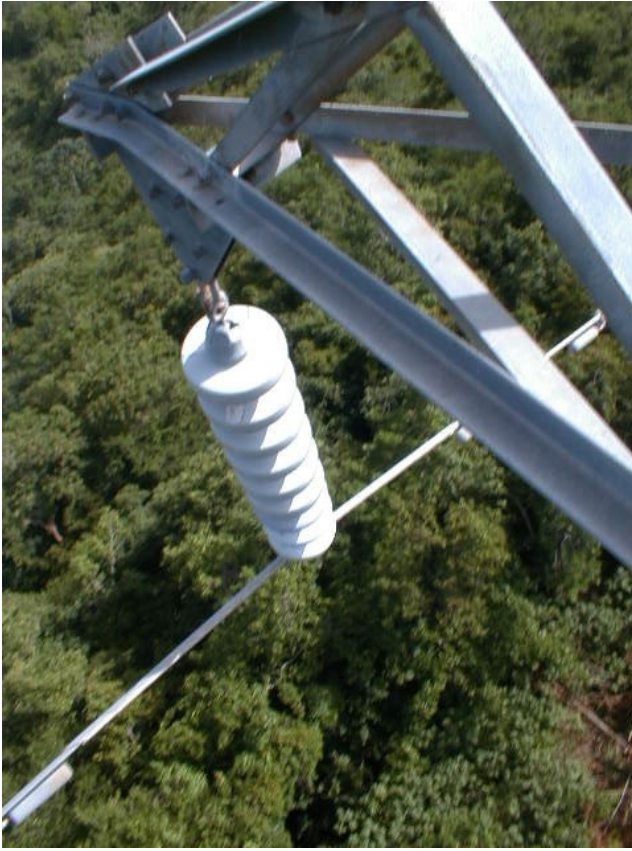
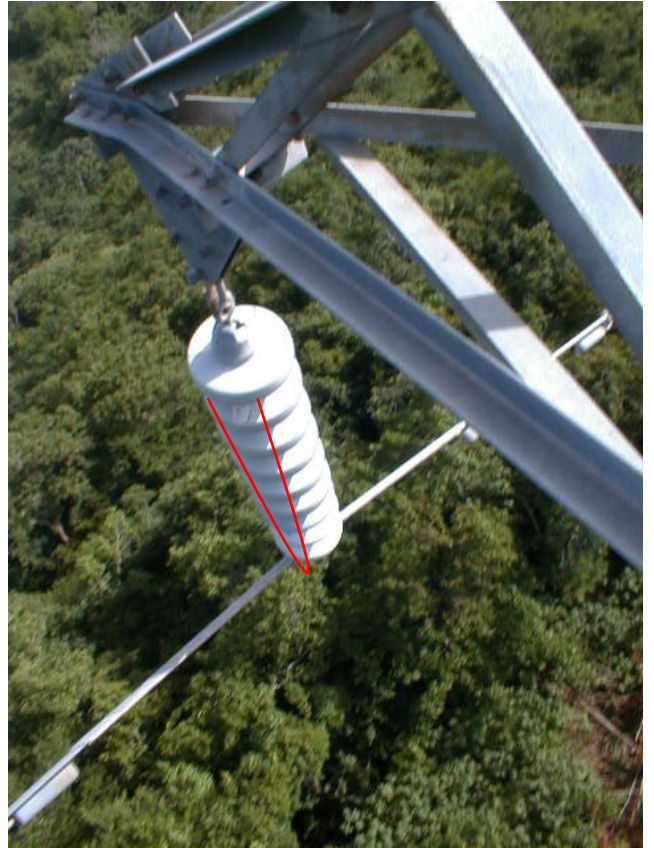
Figure 1: DUNCANS/BOGUE -T75_OUTER PH1_060715

Based on the available evidence namely a) the recording of the fault by the Duncans/Bogue 138 kV transmission line distance relay at Bogue and b) the burn marks on 3 insulator strings at Steel Tower #75 (refer APPENDIX 3), it is concluded that the initiating cause of the incident was a lightning strike to the line or tower on the Duncan/Bogue 138 kV transmission line, resulting in a three-phase ground fault.

The insulator strings on the Duncans/Bogue 138 kV transmission line reflect relatively minor damage and would be indicative of a flash-over which is not sustained or if sustained, the fault current would have to be of comparatively low level. A high current sustained fault would probably have melted or shattered some of the insulators, assuming that this is indeed the initiating cause of the incident. However, the severe voltage depression noted throughout the transmission system does suggest that the fault was indeed maintained for several seconds.

**INSULATOR STRINGS WITH BURN MARKS AT
TOWER # 75 ON THE DUNCANS/ BOGUE 138kV
TRANSMISSION LINE**
