Office of Utilities Regulation

**Enquiry into JPS Power System  
Shutdown of July 3, 2007**

**Enquiry Report**

**DOCUMENT NUMBER:** Ele 2007/07

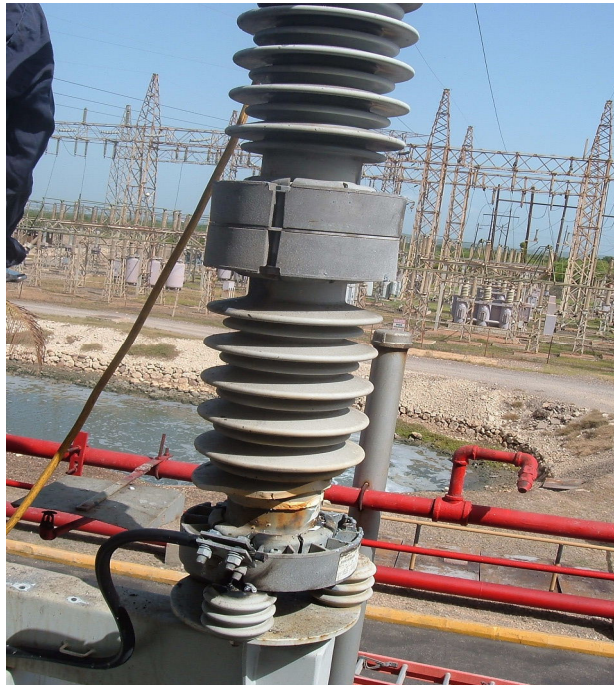
Inspection of Old Harbour Unit No. 2 transformer and arresters revealed evidence of pitting and outright burn-through of the corona rings for the H3 (C-phase) and H2 (B-phase) lightning arresters. There is also a burnt ground lead connector on the C-phase Arrester, as well as, and other signs of scorching.

**Photo #1: Burnt ground conductor connector at base of outer phase arrester**

- 1) Replaced lightning arresters for Unit No. 2 generator step-up transformer.
- 2) Timing verification performed for breakers 9-220, 9-520, 9-320, 9-830, 9-630, 9-420A & 9-320A.
- 3) Performed timing tests on breaker fail timers for 9-220, 9-320, 9-420, 9-520 and 9-430B
- 4) Repaired jumper for disconnect switch 9-227
- 5) Accelerated contamination mitigation programme (insulator cleaning)
- 6) Accelerated general maintenance of Old Harbour switchyard.
- 7) Replaced circuit breaker 9-220 with SF-6 type circuit breaker.

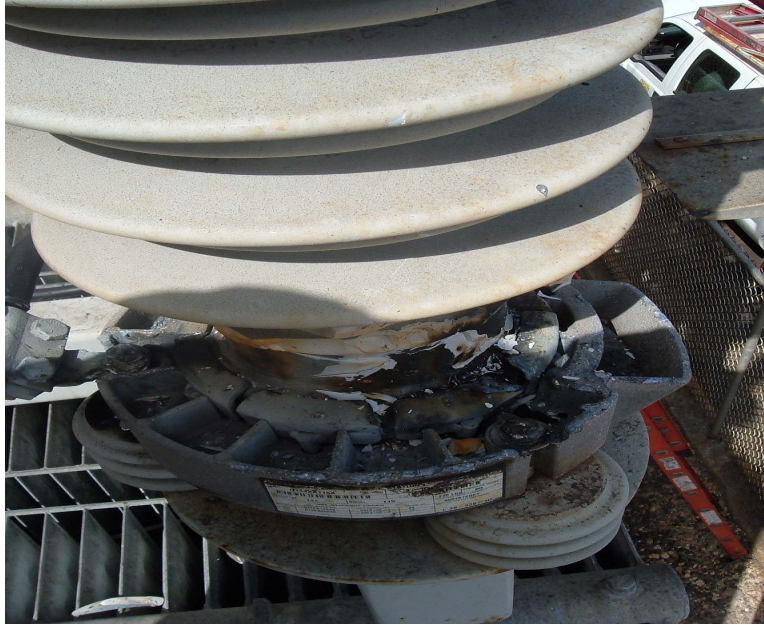
**Photo #2: Burnt outer phase arrester base**

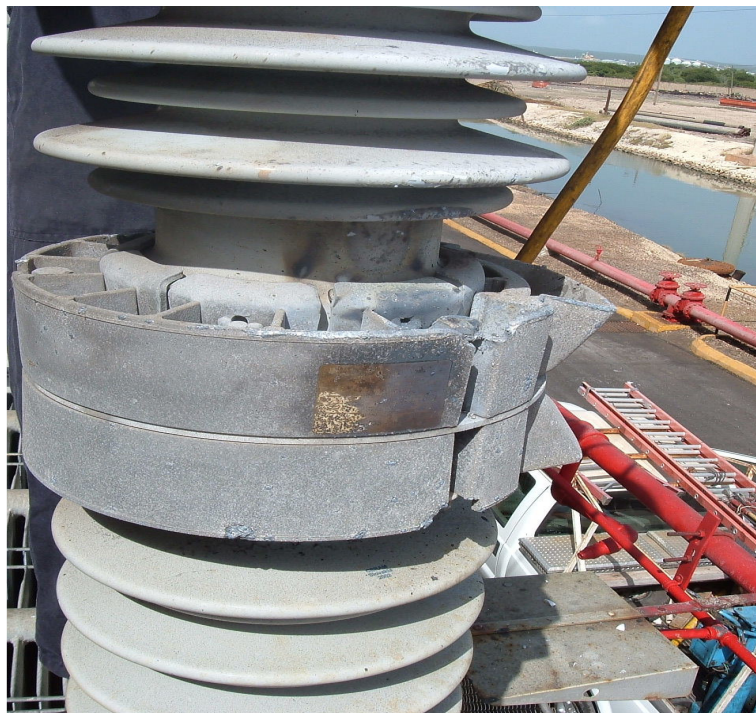
**Photo # 3: Scorching on middle phase arrester**

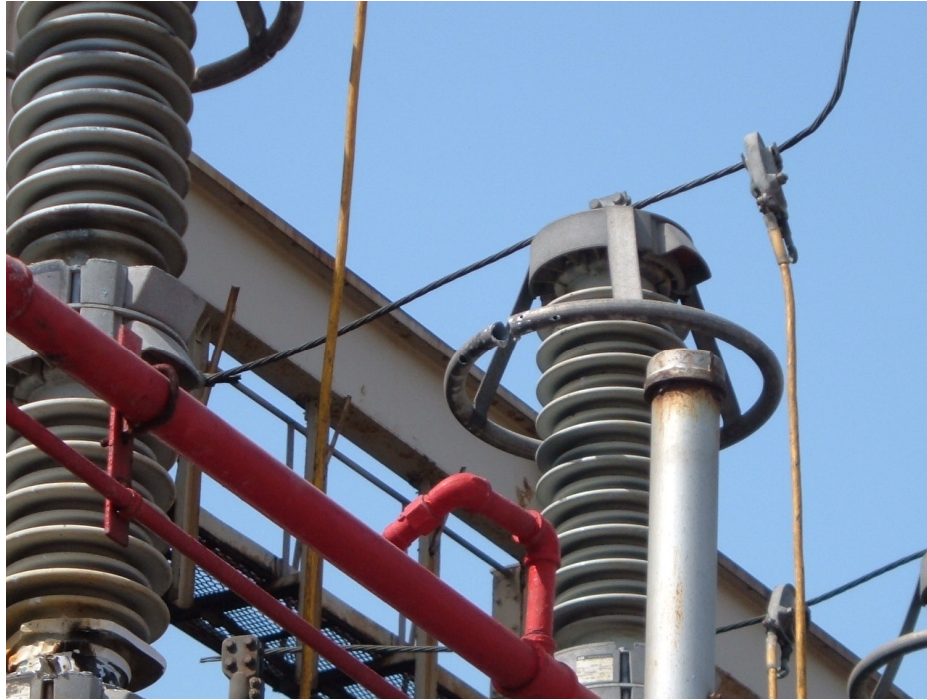
**Photo #4: Burn-through of corona ring at top of arrester – middle phase**

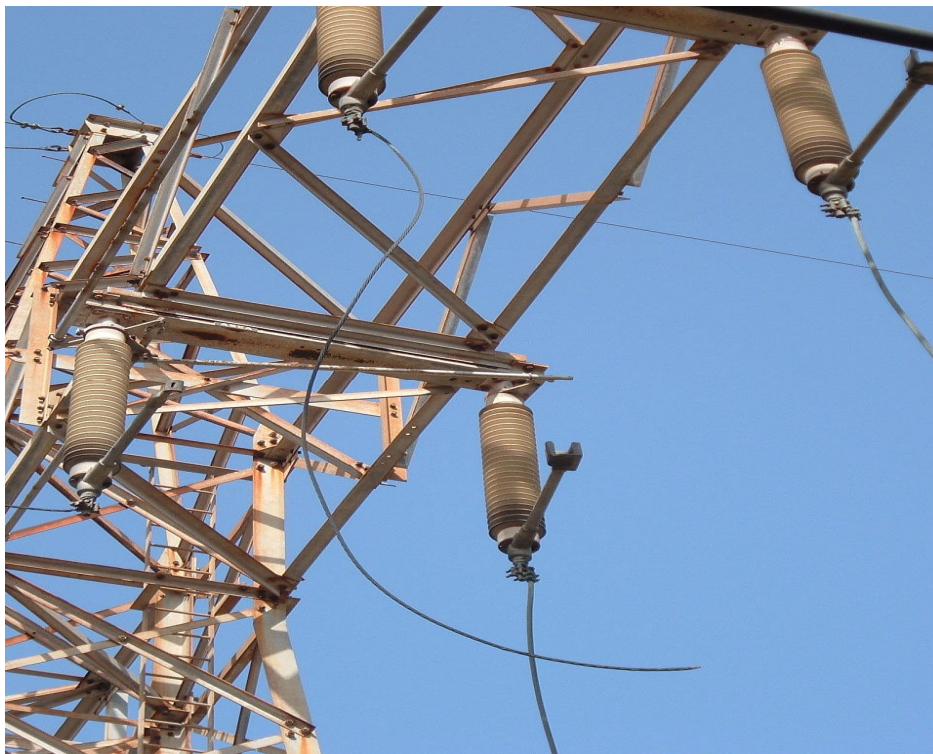
A burnt B-phase down-dropper was observed on the line side of disconnect switch 9-227. Disconnect switch 9-227 is used to isolate Unit No. 2 and its generator step-up transformer from the 138 kV grid.

**Photo #5: Dislodged down dropper on middle phase of disconnect switch 9-227**

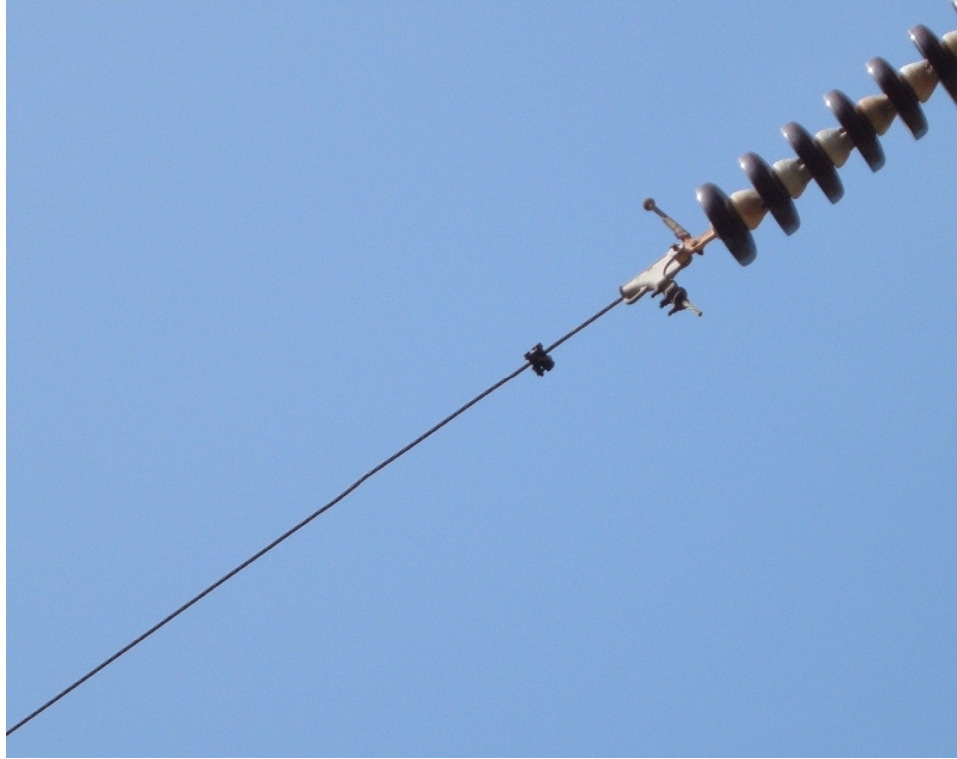
**Photo #6: Connector for the dislodged down dropper for disconnect switch 9-227**

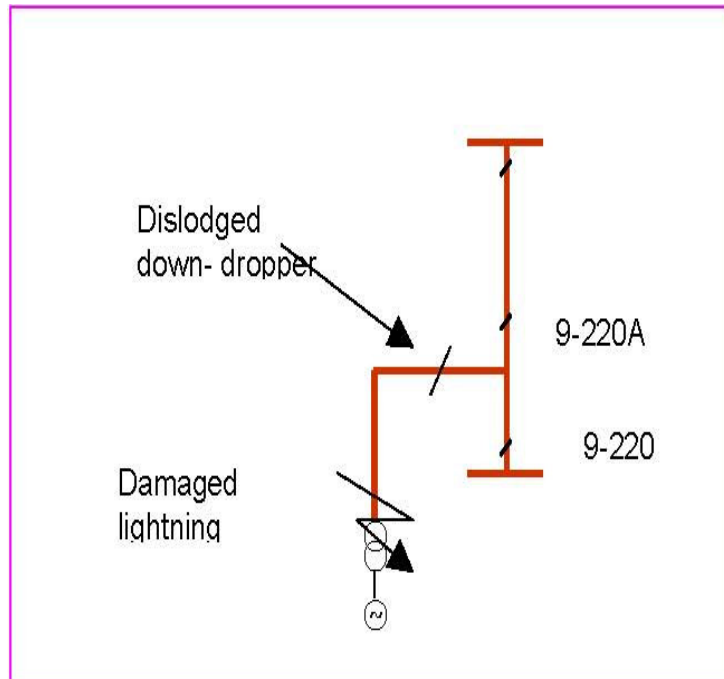
## **APPENDIX 6 - Old Harbour Switchyard Layout Diagram Showing 138KV Circuit Breaker Positions**

7. However, while one of the connecting circuit breakers operated correctly the second circuit breaker (9-220) failed and only tripped after a full four (4) seconds. This failure is attributed to the sticking of one pole of the three-pole breaker as verified by subsequent inspection.

For the damaged lightning arresters and the dislodged down-dropper on disconnect switch 9-227, breakers 9-220 and 9-220A are required to trip along with the generator.
