**Enquiry into JPS Power System
Shutdown of January 9, 2008**

Preliminary Report

February 12, 2008

**Preliminary Report of the Panel Established by the
Office of Utilities Regulation
To Enquire into
The All-Island Electricity System Shutdown of 9th January 2008**

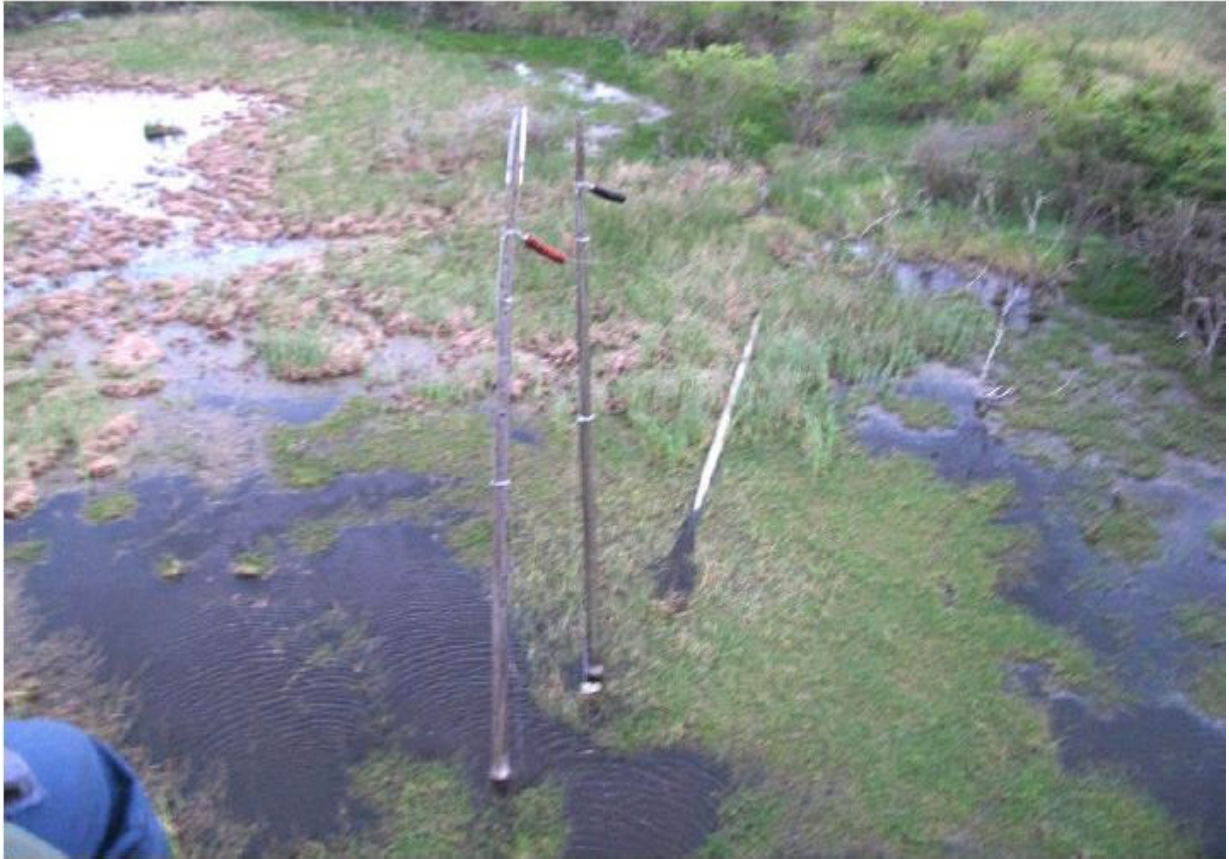
- Investigations carried out by JPS immediately after the shutdown revealed that a pole supporting one of the transmission line conductors (wires) and located less than two (2) miles from the Duhaney substation had toppled over, permitting current to flow from the conductor directly to the ground, precipitating an unstable condition since a short-circuit (fault) then developed.
- The protective devices intended to isolate faults on the transmission system operated correctly at Duhaney, cutting off the flow of current from that substation to the fault location.

JPS reports that the pole which toppled over was located in a swamp and the water was about four (4) feet deep at that location (See picture of fallen pole attached). The guy wire supporting the pole had pulled out of the ground and consequently the pole fell over. (A guy wire is a length of wire attached to the upper section of the pole at one end and anchored in the ground at the other end, thereby increasing the stability of the pole). The strength of the guy's anchor in the earth may have been weakened because of the waterlogged condition of the ground. The pole was reinstalled in its original location by JPS crews. The pole was inspected by the Panel after its reinstallation and no evidence was found of rot or other conditions that would render it unsuitable for continued service.

- Transmission line inspection. The transmission line on which the fault developed had not been inspected at ground level since 2002. At that time the water level at the base of the poles was not as deep as it now is. It should therefore have been expected that the stability of the poles' foundation would have been weakened by the high moisture content of the soil in which they were now fixed and some attention paid to evaluation of the resulting risk. Ground-level inspection would not necessarily have indicated that the security of the poles in general, or of any specific pole, was endangered, but would nevertheless have been a prudent precautionary measure.

Aerial inspections were undertaken in December 2004 and October 2005 but these would have provided information primarily about the top of the poles - the cross arms, insulators and conductors, but not very much about the foundations. However, the pictures taken from the air on that occasion showed the poles standing in a large lake of water and should have raised concern about the security of the foundations.

Picture showing fallen pole on structure # 18 on JPS Tredegar to Duhaney 138 kV transmission line
