# Office of Utilities Regulation

## FLOW OUTAGE REPORT

**PUBLIC VERSION**

2018 July 23

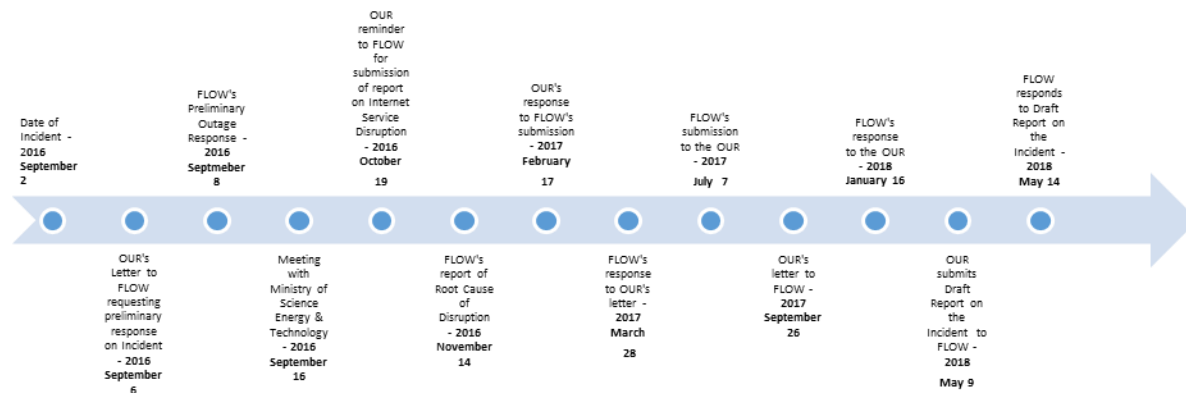
*Figure 1 Timeline of Activities related to FLOW's Internet Disruption that occurred on 2016 September 2*
