JPS POWER SYSTEM INTEGRITY INVESTIGATION

**REPORT OF THE INVESTIGATION COMMITTEE
INTO
THE PUBLIC ELECTRICITY SYSTEM SHUTDOWN
OF AUGUST 5, 2012
AND
RELIABILITY OF THE POWER GRID**

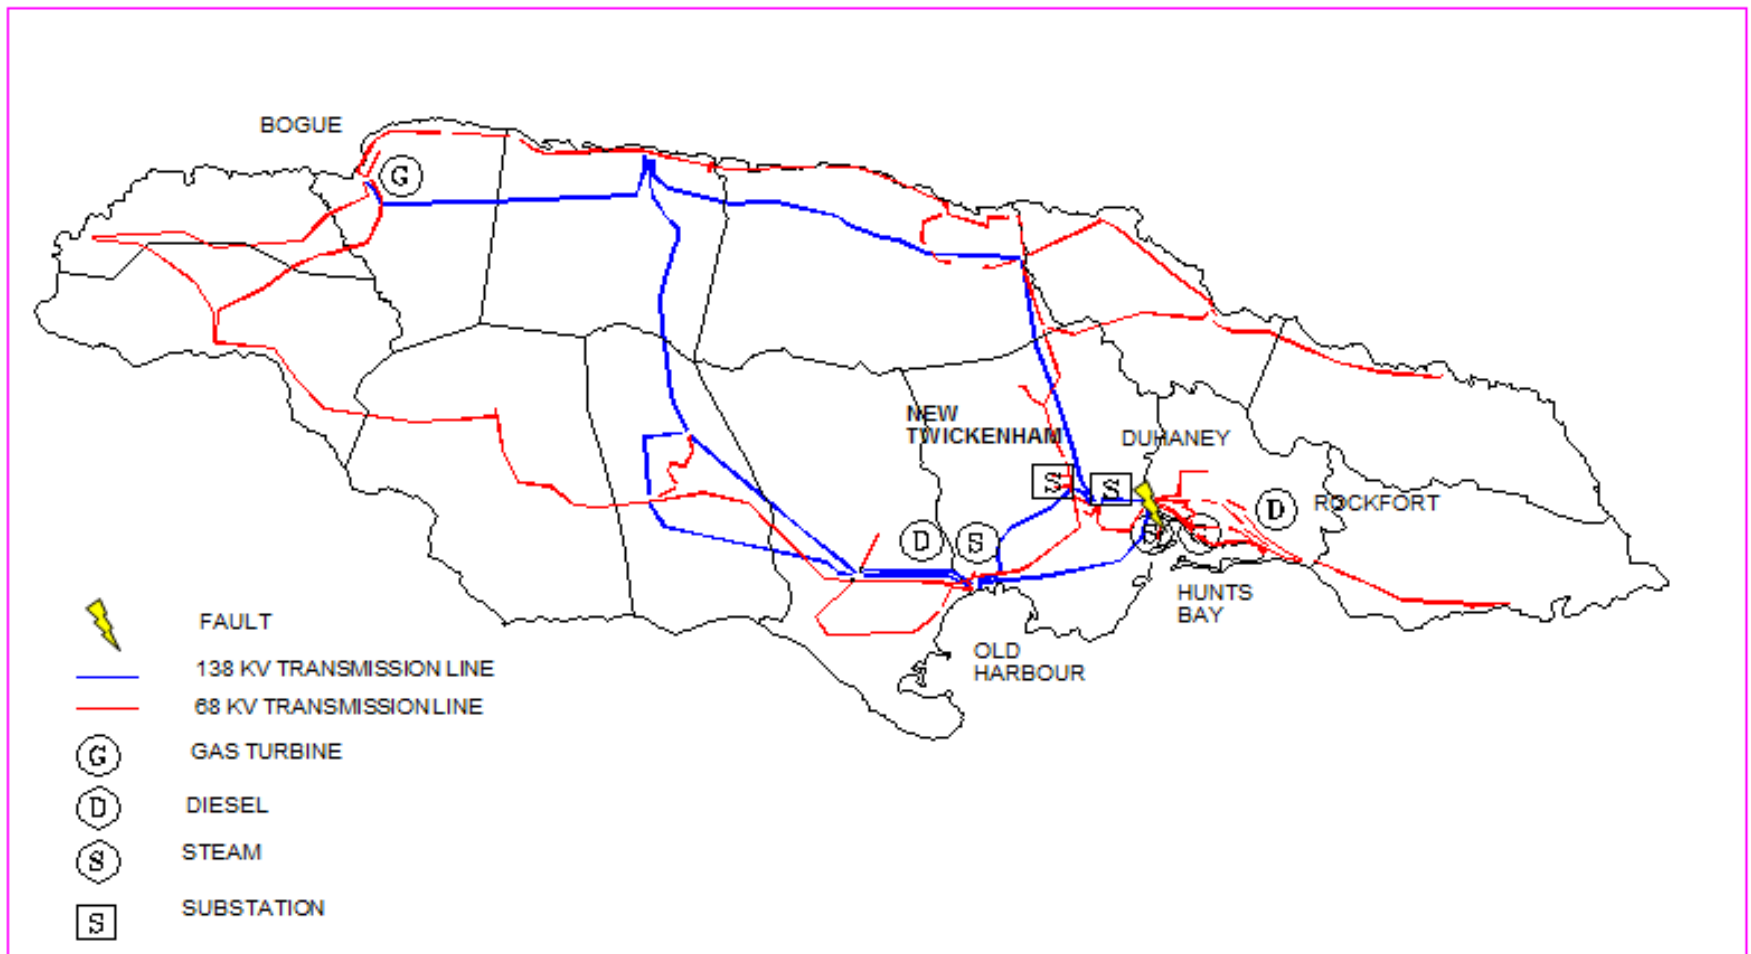
Figure 1: Geographic Layout of Major JPS Transmission Lines and Fault Location

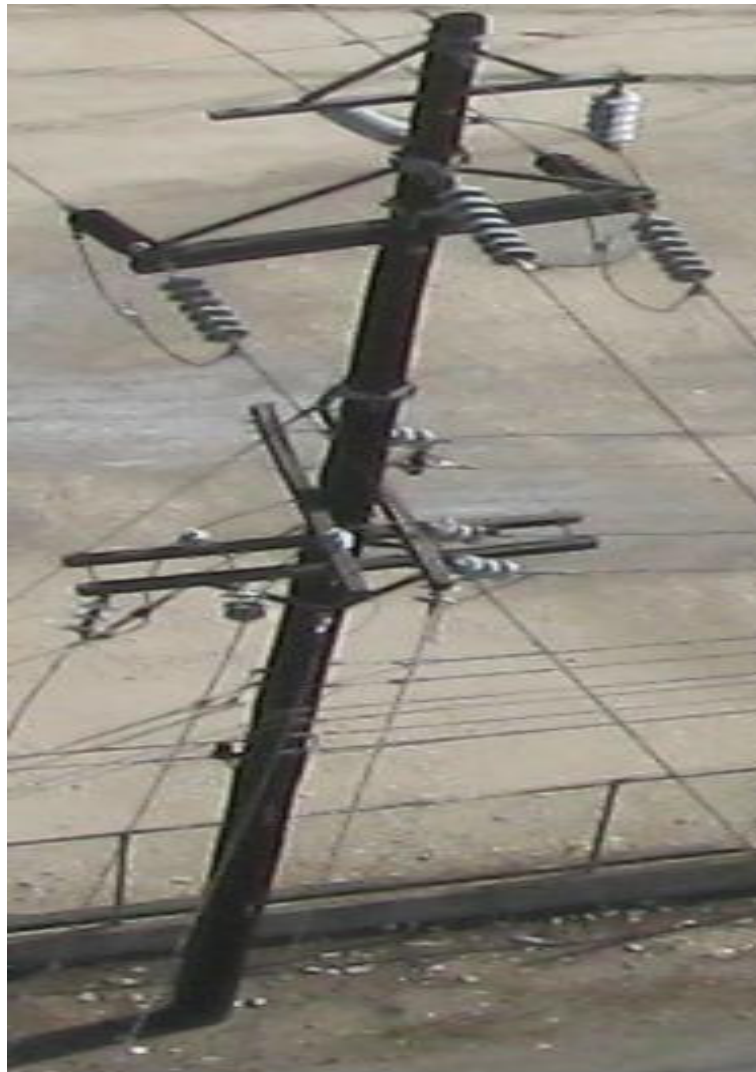
Figure 4: Photo of Faulted Pole Structure #1 on the Duhaney to Naggo Head 69kV Line

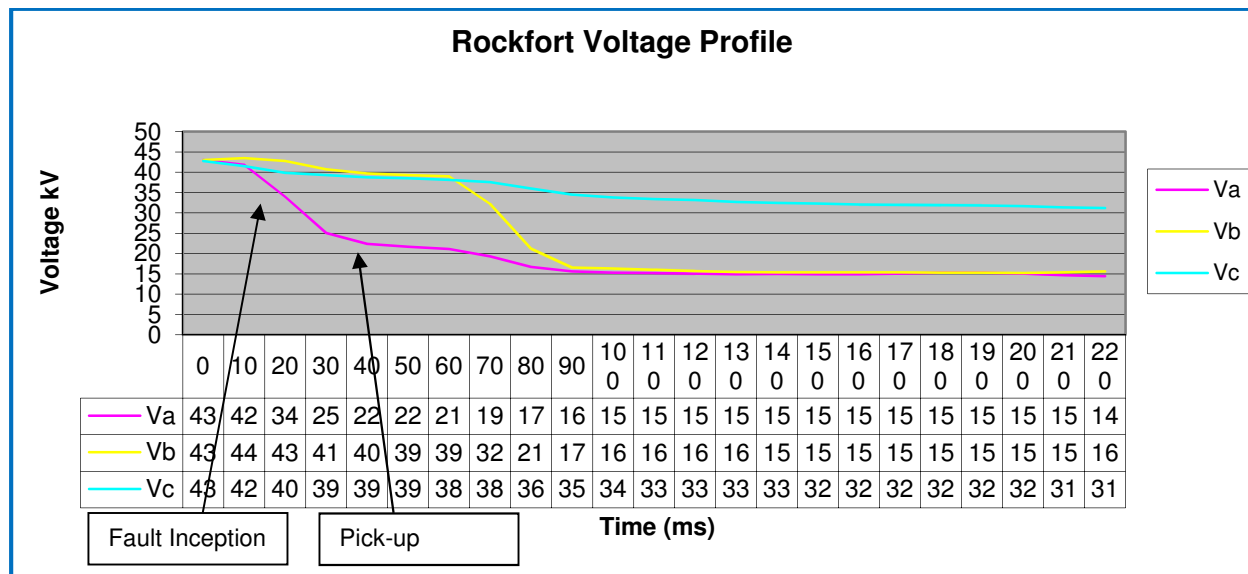
Figure 7: Rockfort Voltage Profile during the Fault

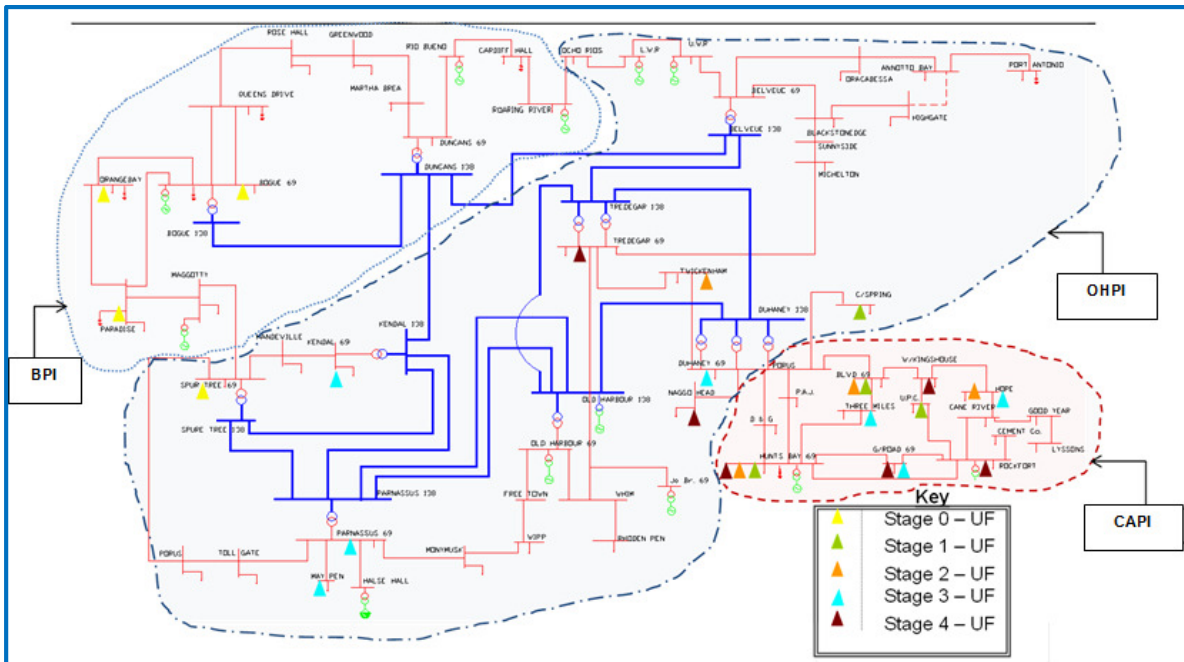
Figure 10: Illustration of Power Islands and UFLS Points

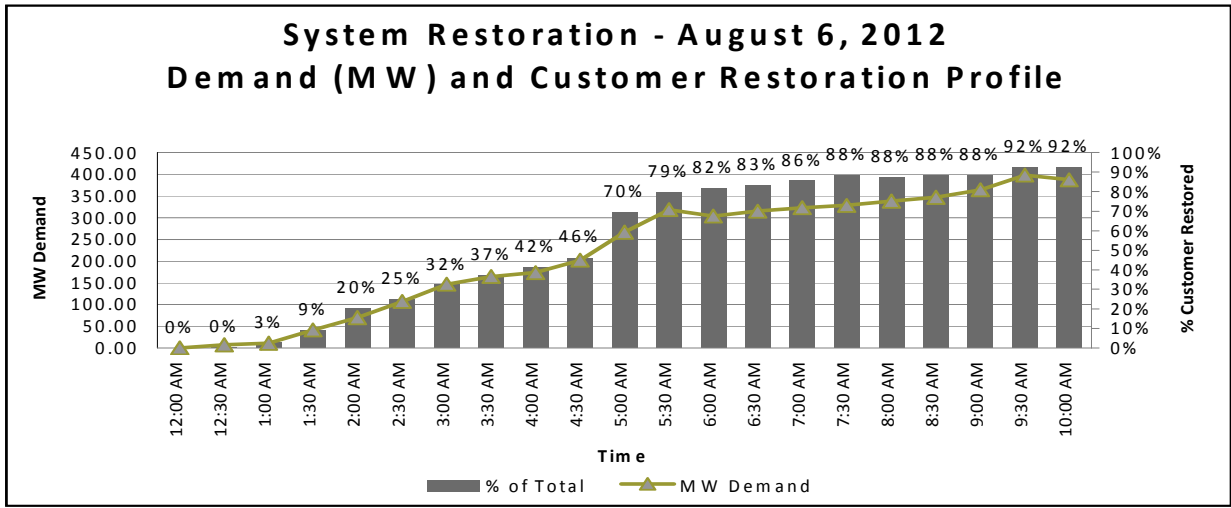
Figure 11: System Restoration Profile

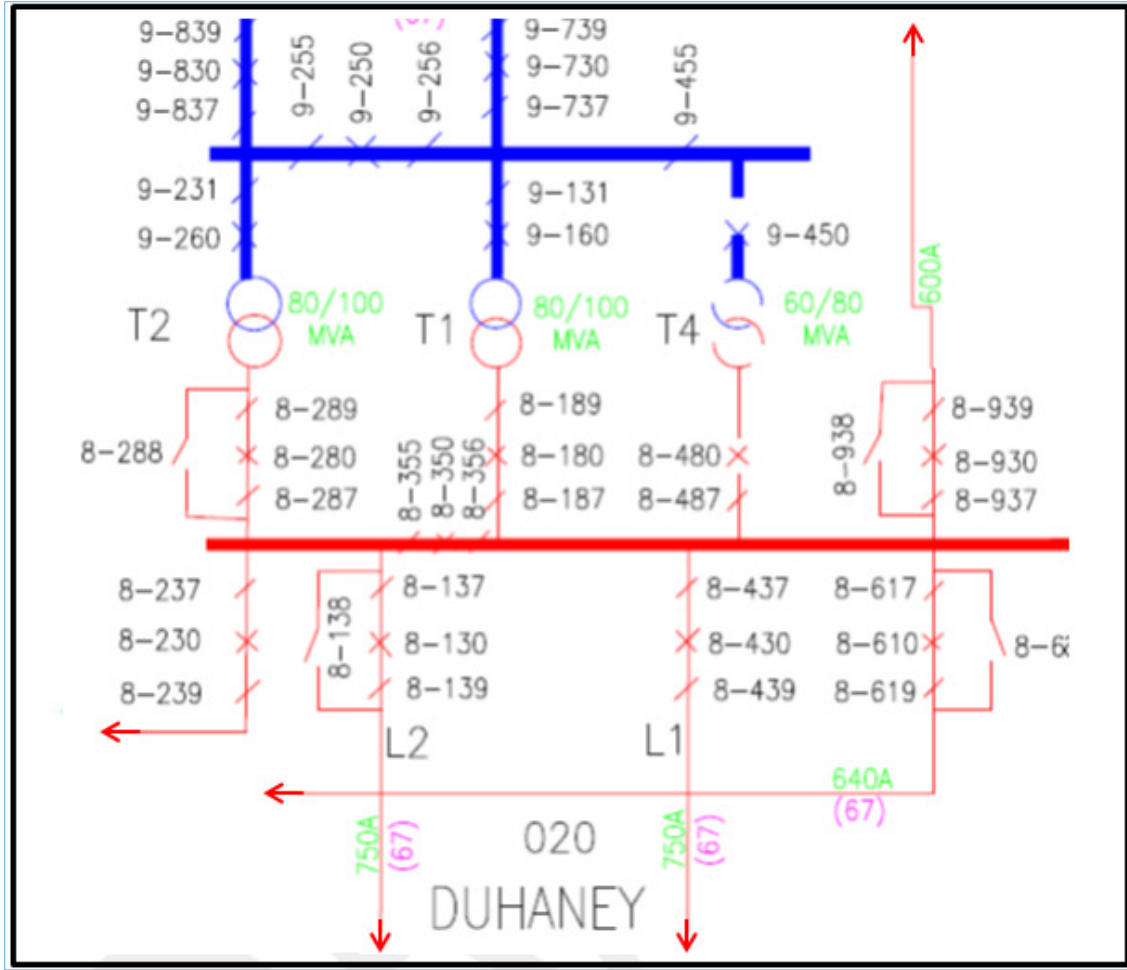
Figure 12: One Line Diagram of Duhaney substation

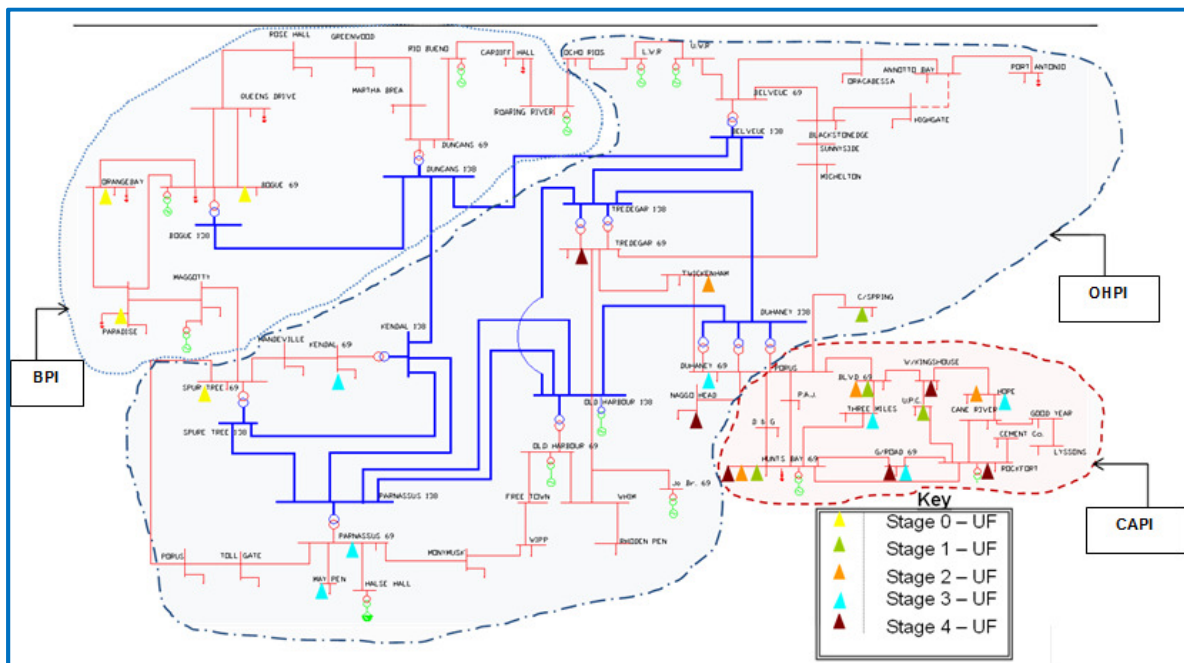
Figure 1: Illustration of Power Islands and UFLS Points

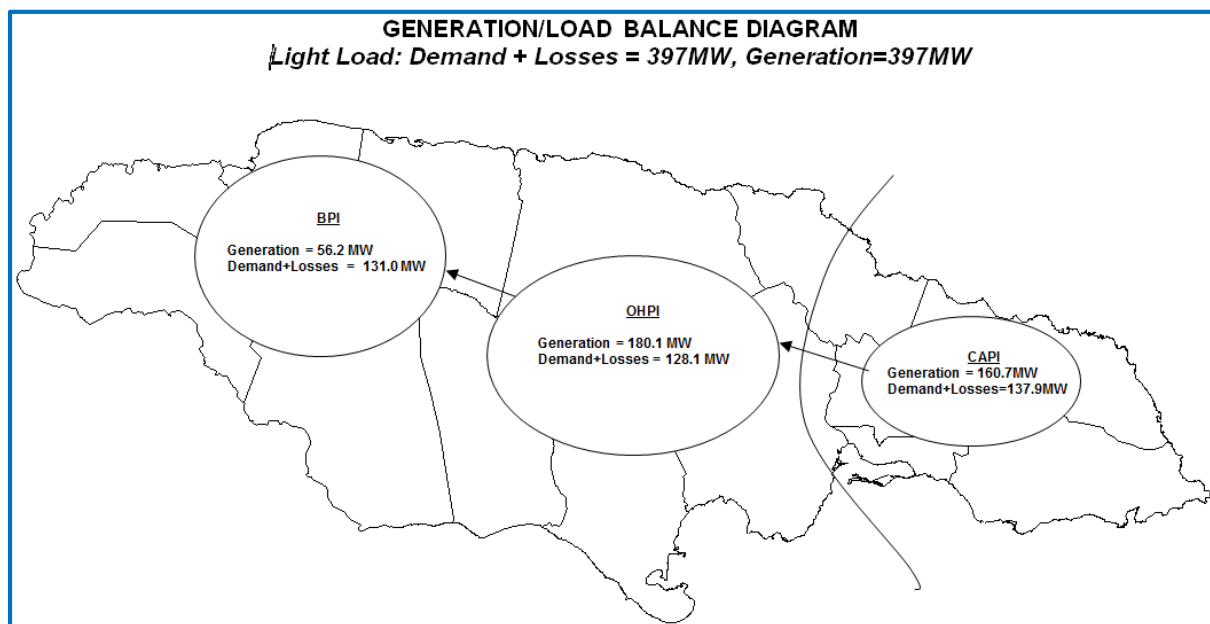
Figure 2: Generator/Load Balance Diagram
