**Jamaica Public Service Company Limited**

**CHANGING LIVES WITH OUR *e*NERGY**

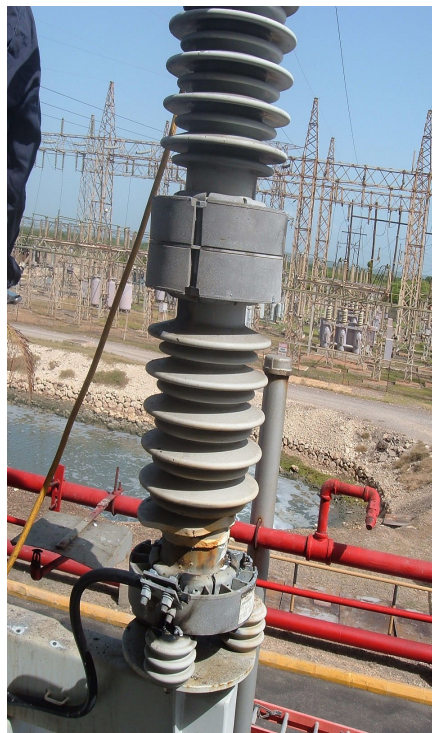
Figure 4-1 Burnt ground conductor connector at base of outer phase arrester

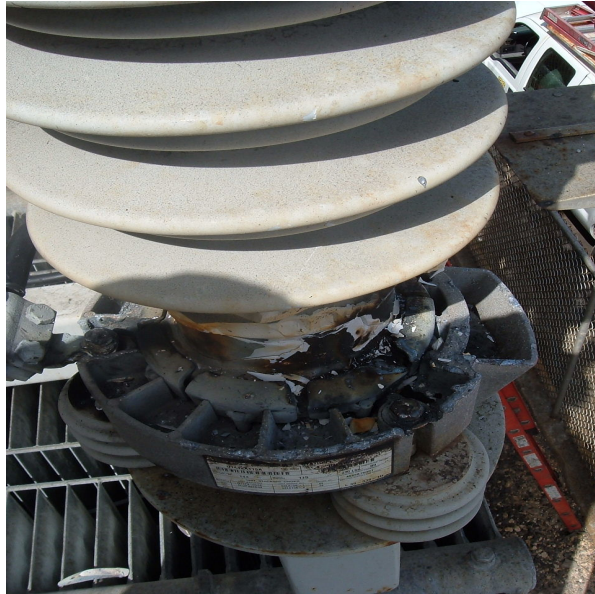
Figure 4-2 Burnt outer phase arrester base (same arrester as in figure 3.1)

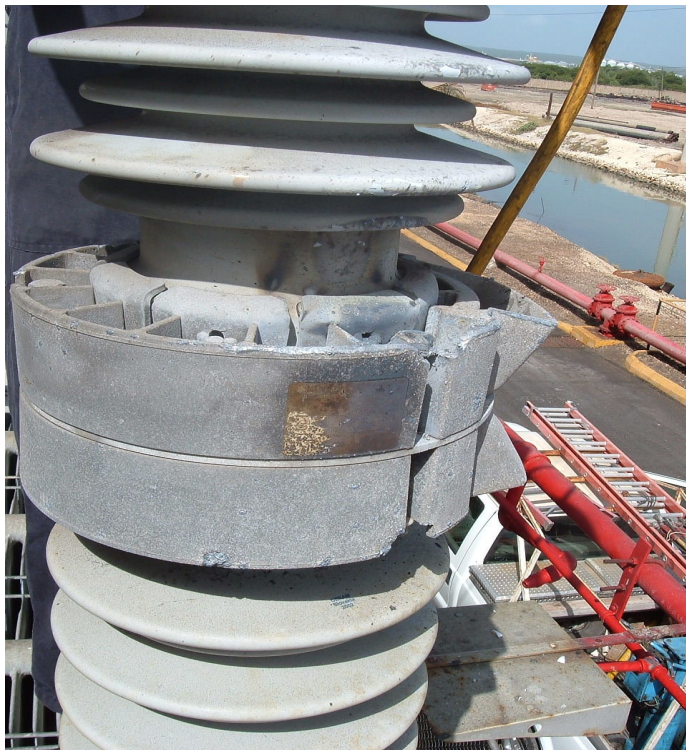
Figure 4-3 Scorching on middle phase arrester

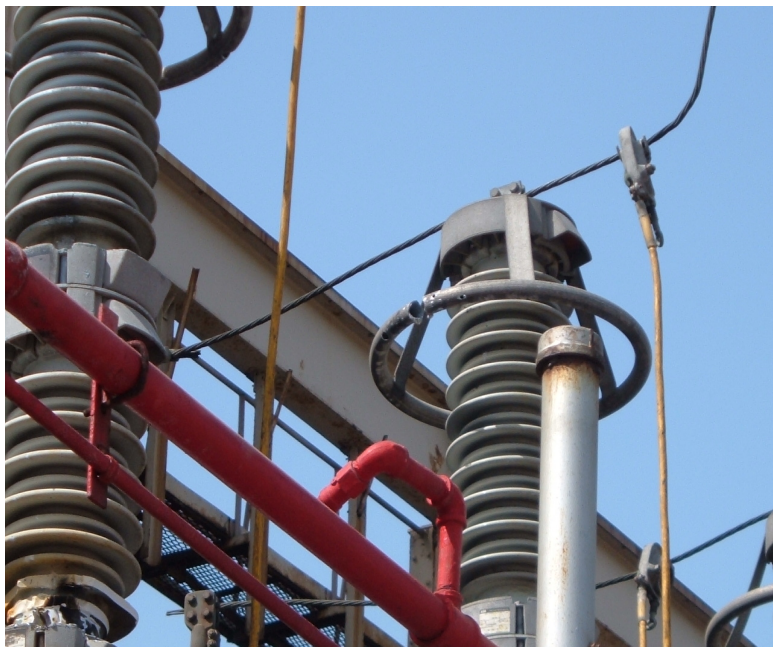
Figure 4-4 Burn-through of corona ring at top of arrester – middle phase

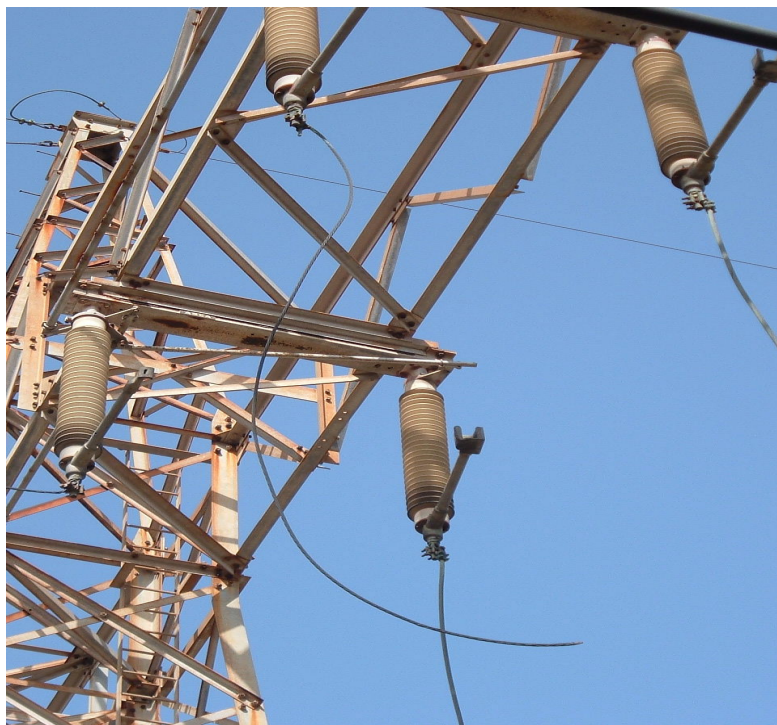
Figure 4-5 Dislodged down dropper on middle phase of switch 9-227

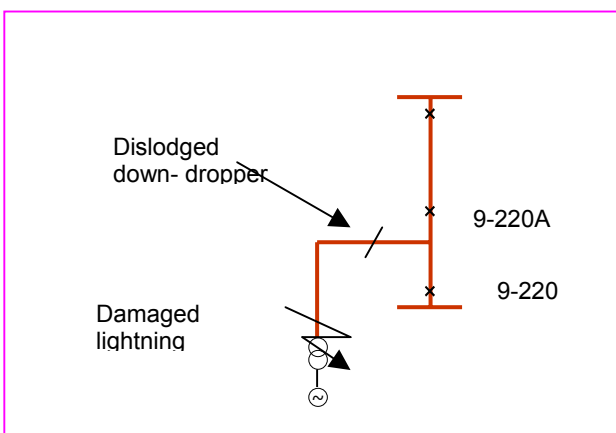
For the damaged lightning arresters and the dislodged down-dropper on disconnect switch 9-227, breakers 9-220 and 9-220A are required to trip along with the generator.

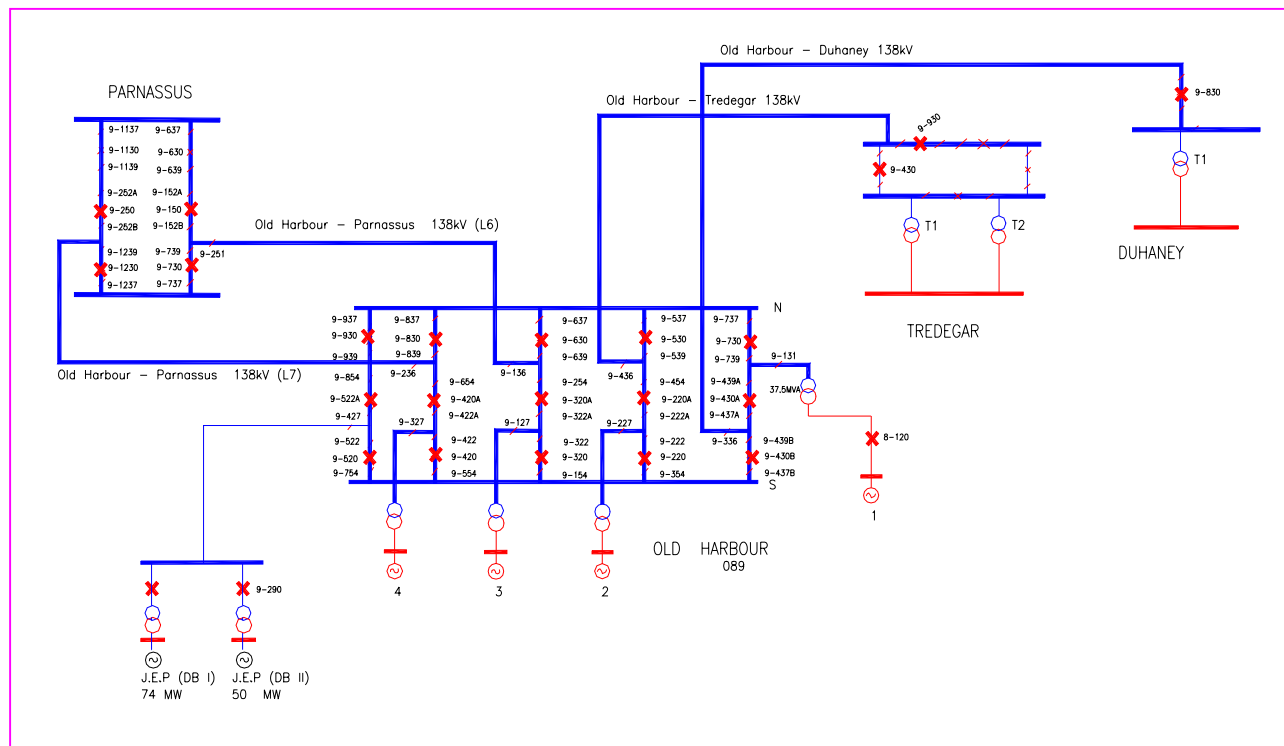
Figure 5-6 Single Line Layout Diagram of Old Harbour and adjacent substations

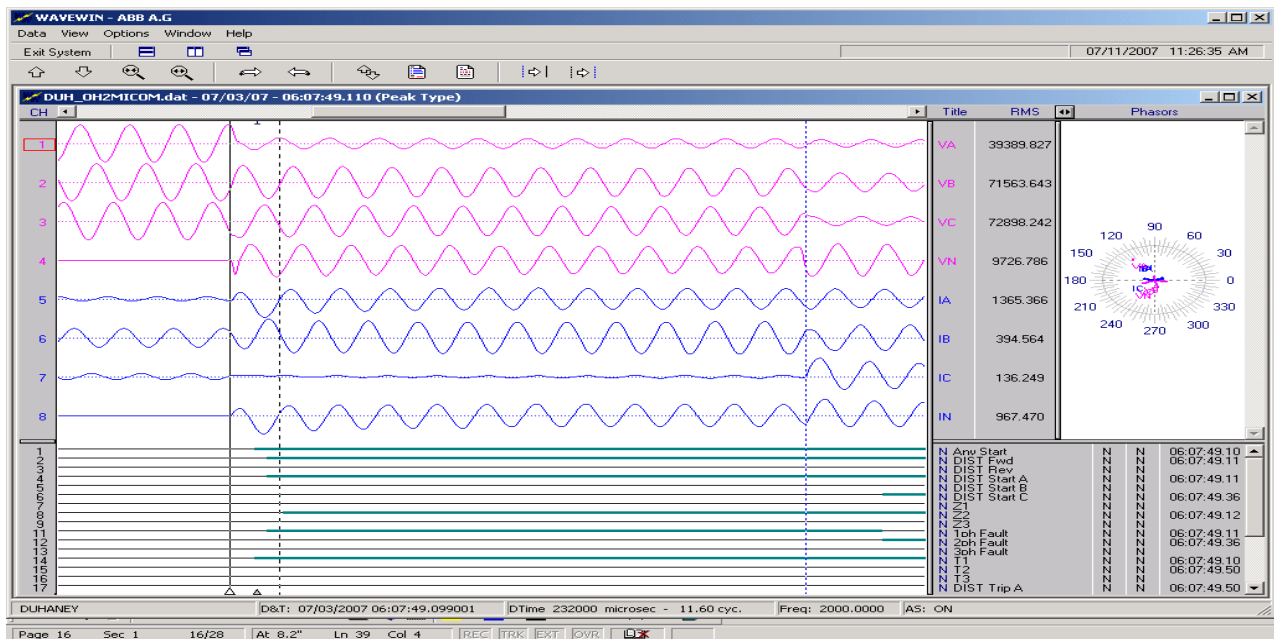
Figure 5-7 Duhaney-Old Harbour Micom P441 Relay Fault Record A-G 232 ms

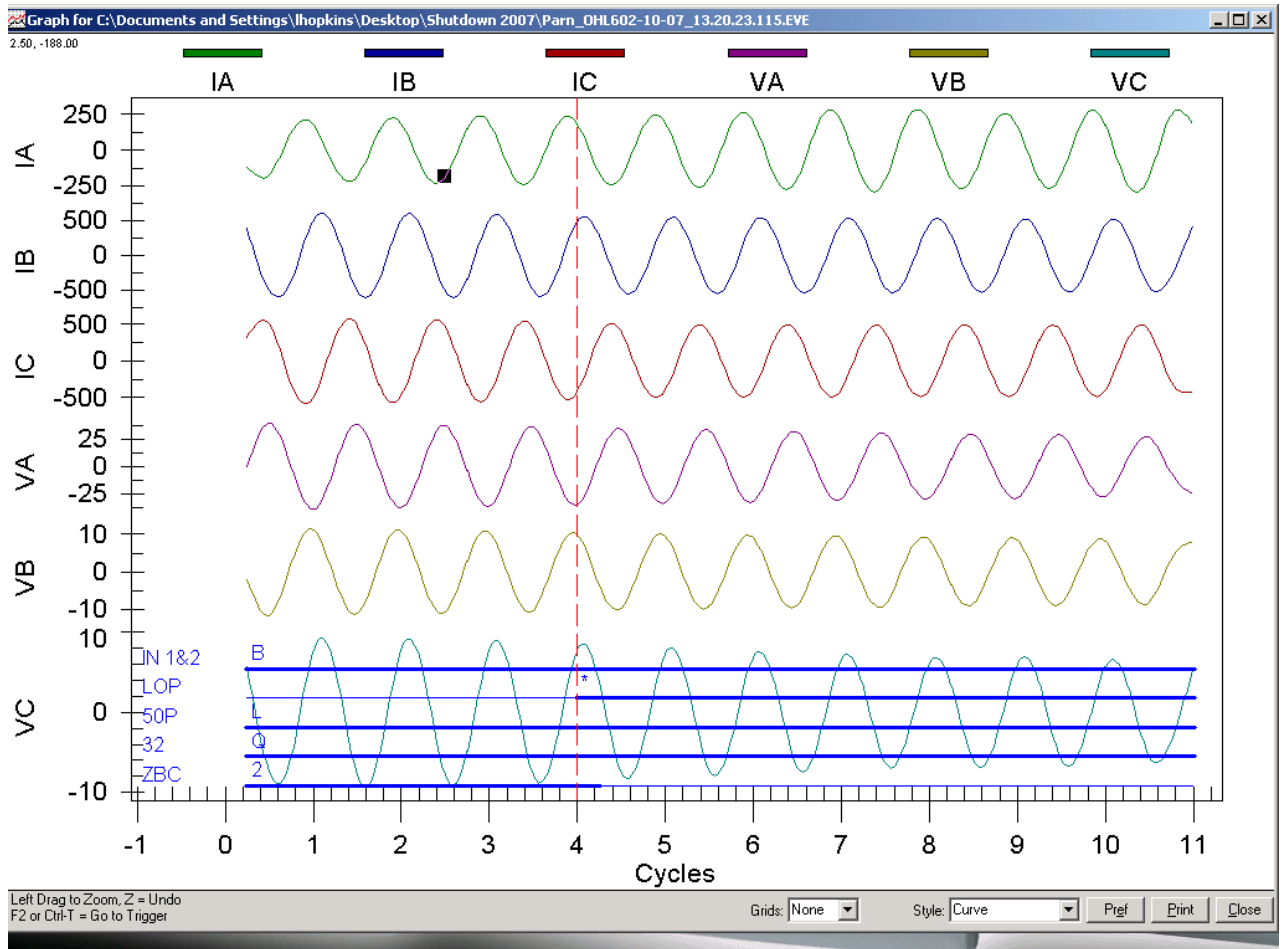
Figure 5-10 Parnassus – Old Harbour 138 kV Line 6

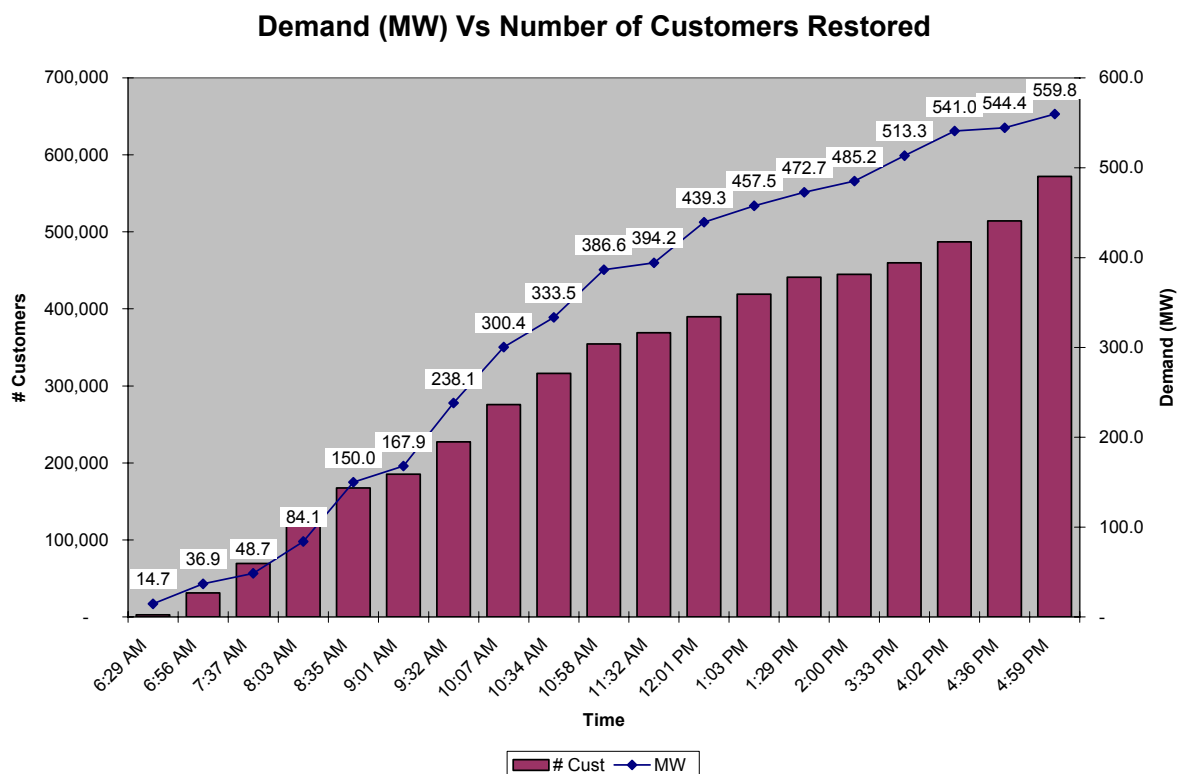
### **7.3.1 Successful Blackstart and Grid Interconnection**
