REPORT OF THE OUTAGE REVIEW TEAM

*Appointed by the
Office of Utilities Regulation*

**TO INVESTIGATE THE
ELECTRICITY SYSTEM TOTAL
SHUTDOWN ON 2016 AUGUST 27**

2017 May 4

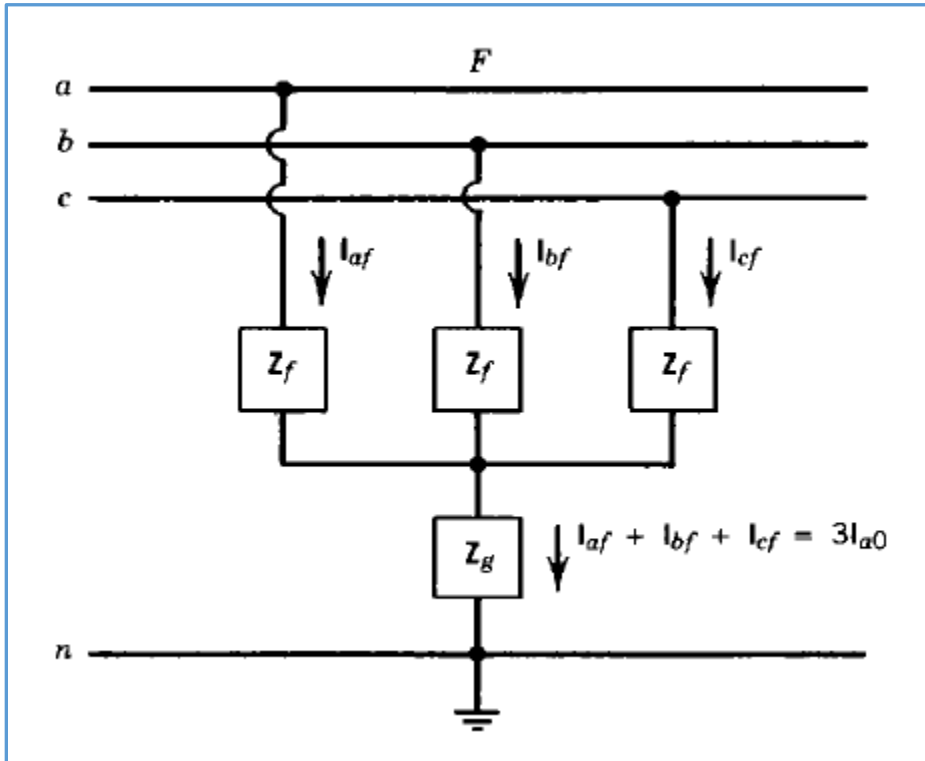
Figure 5.1: General Representation of a Three Phase-to-Ground Fault

A general representation of the three phase-to-ground fault is illustrated in Figure 5.1 below.

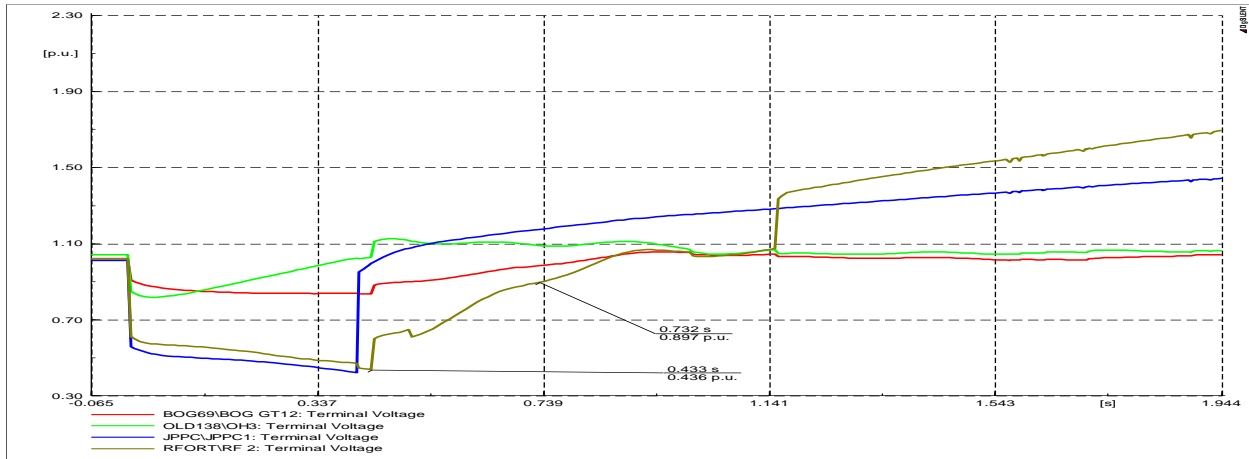
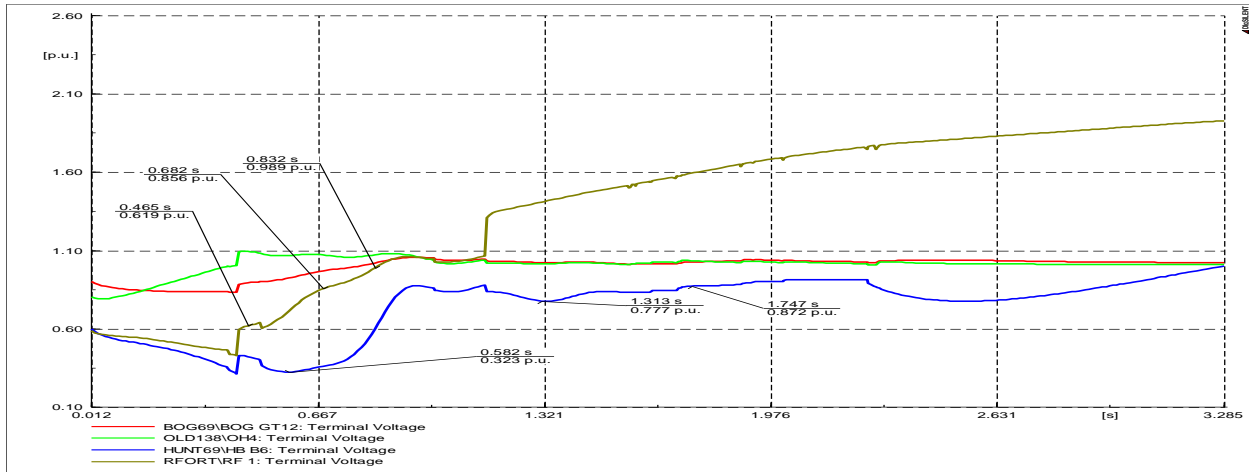
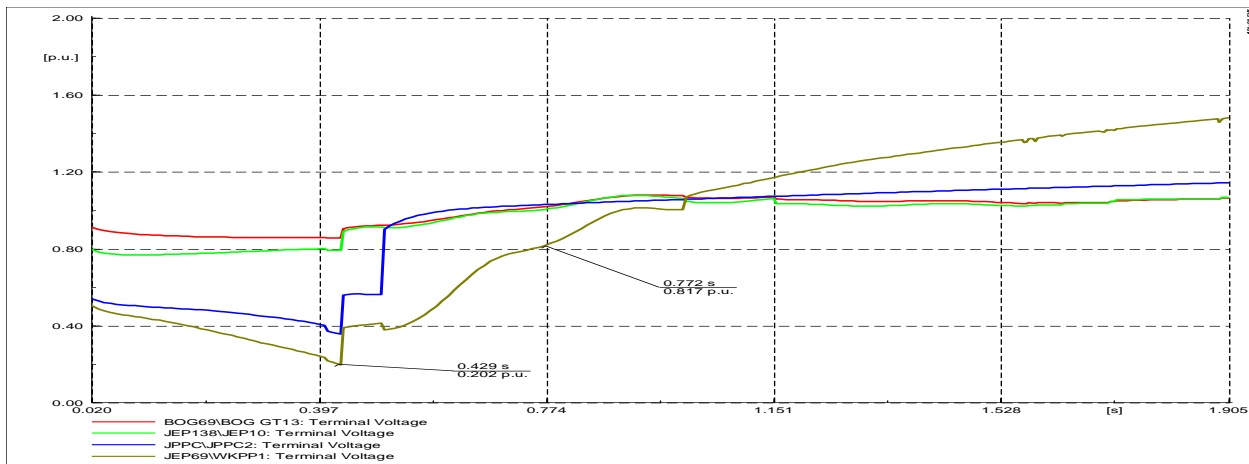
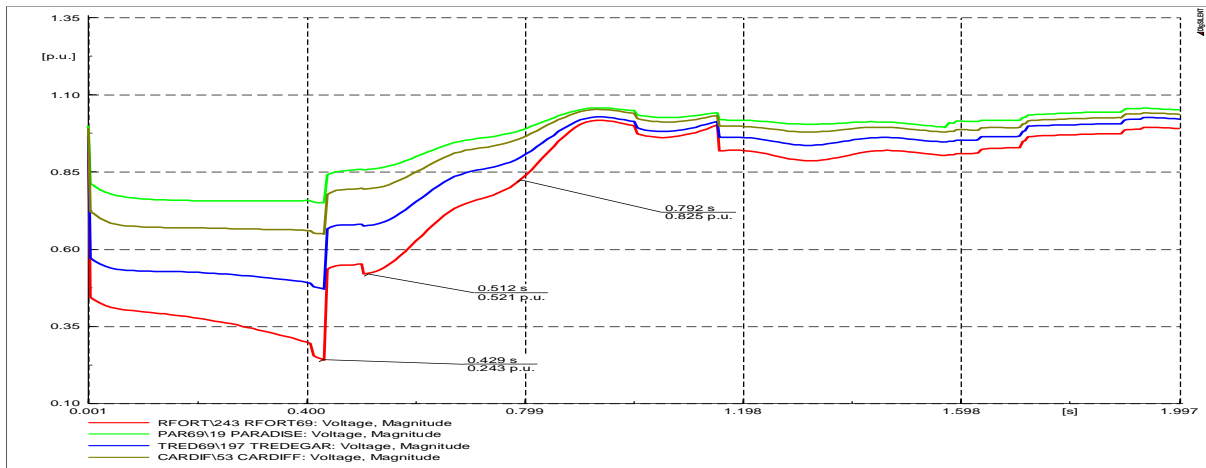
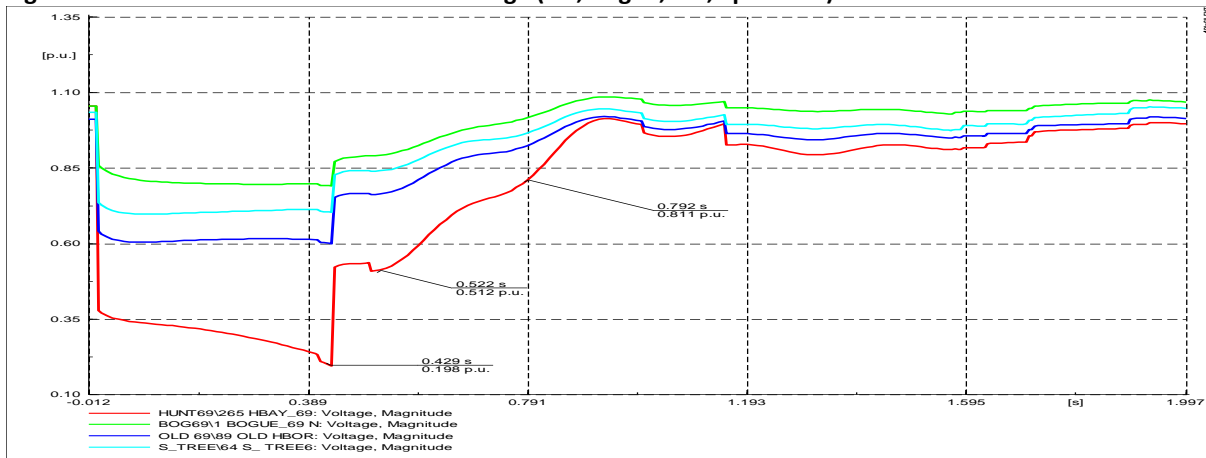
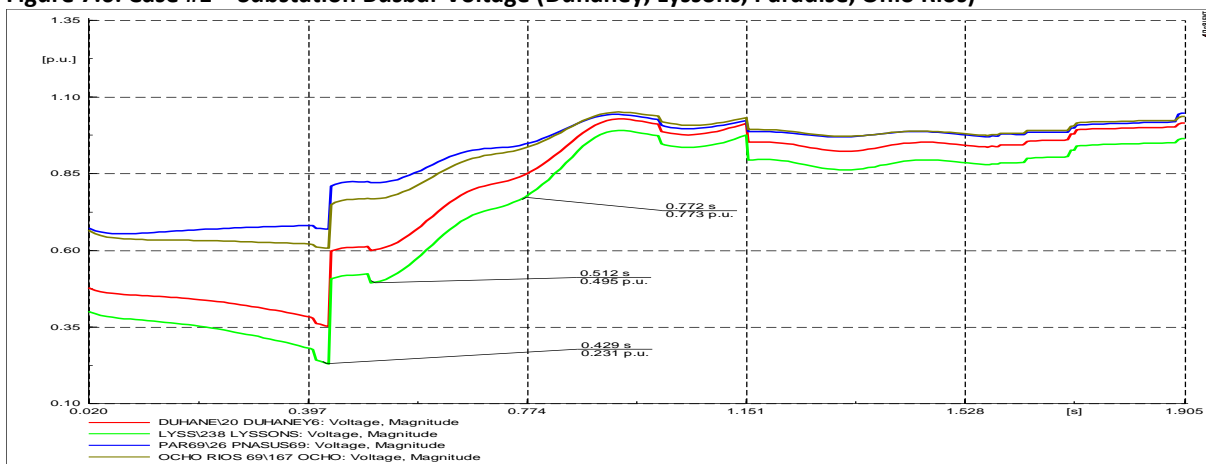
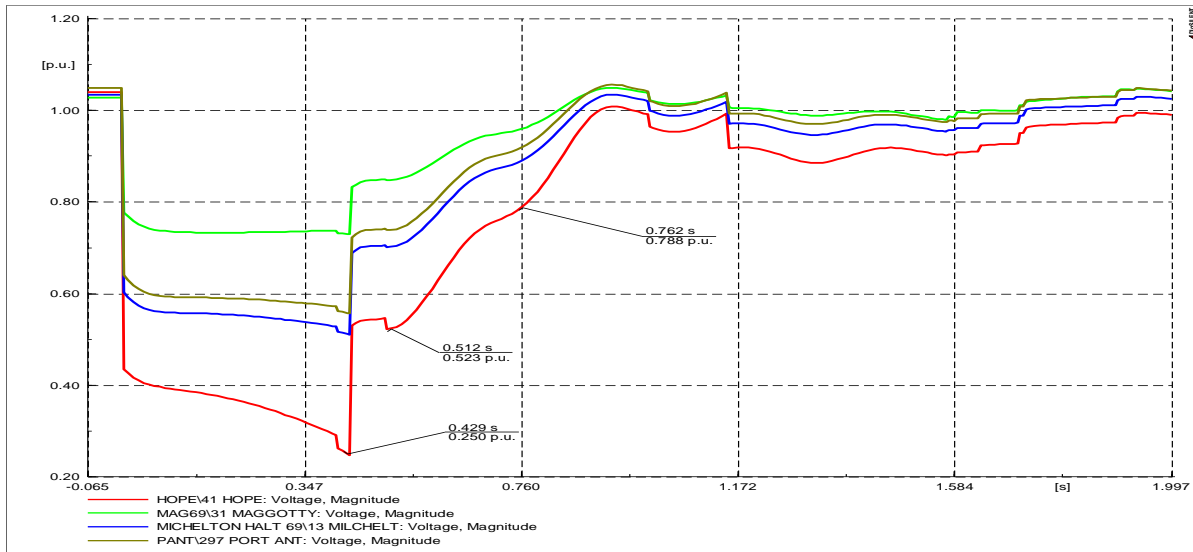
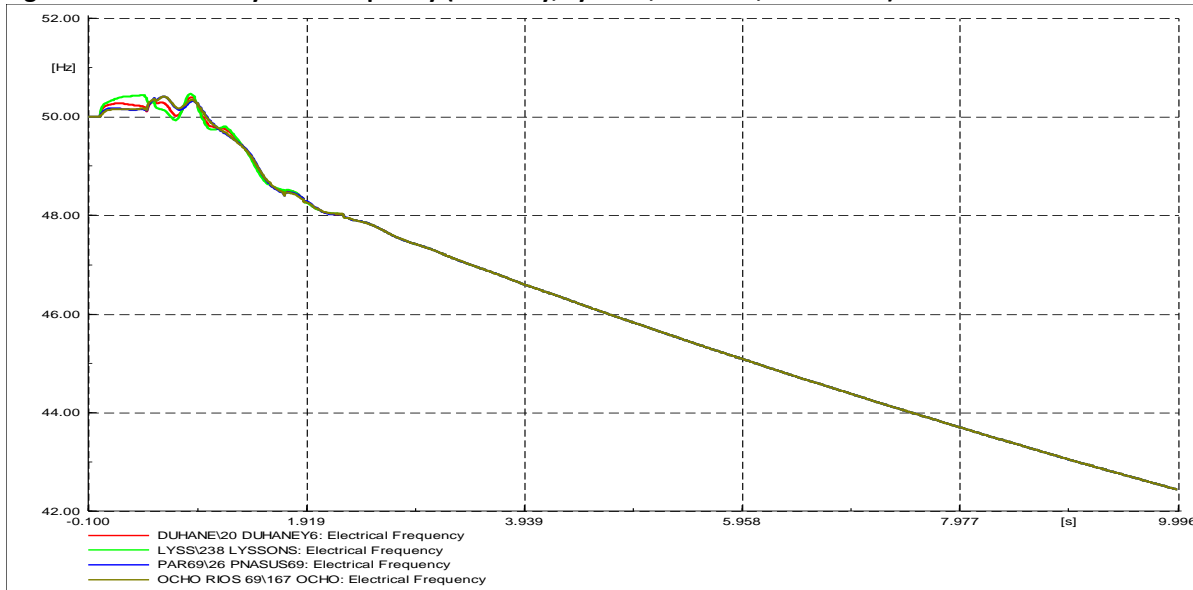
The voltage and frequency plots for Case #1 are given in Figures 7.1 to 7.8 below. The voltage and frequency plots for Cases #2 to #11 are provided in **APPENDIX 3** of this Investigation Report.

Figures 7.1 to 7.8 above give the terminal voltages for selected generators and also bus voltages and frequencies at selected locations throughout the System.
