REPORT ON INVESTIGATION OF JAMAICA PUBLIC SERVICE COMPANY LIMITED MAJOR SYSTEM FAILURE POWER SYSTEM ISLANDING AND WIDESPREAD OUTAGE 2016 APRIL 17 at 6:59 p.m.

DOCUMENT TITLE AND APPROVAL PAGE		
1. DOCUMENT NUMBER:		
2. DOCUMENT TITLE: Report on Investigation of Jamaica Public Service Company Limited Major System Failure, Power System Islanding and Widespread Outage 2016 April 17 at 6:59 p.m.

2016 April 17 JPS System Outage Analysis

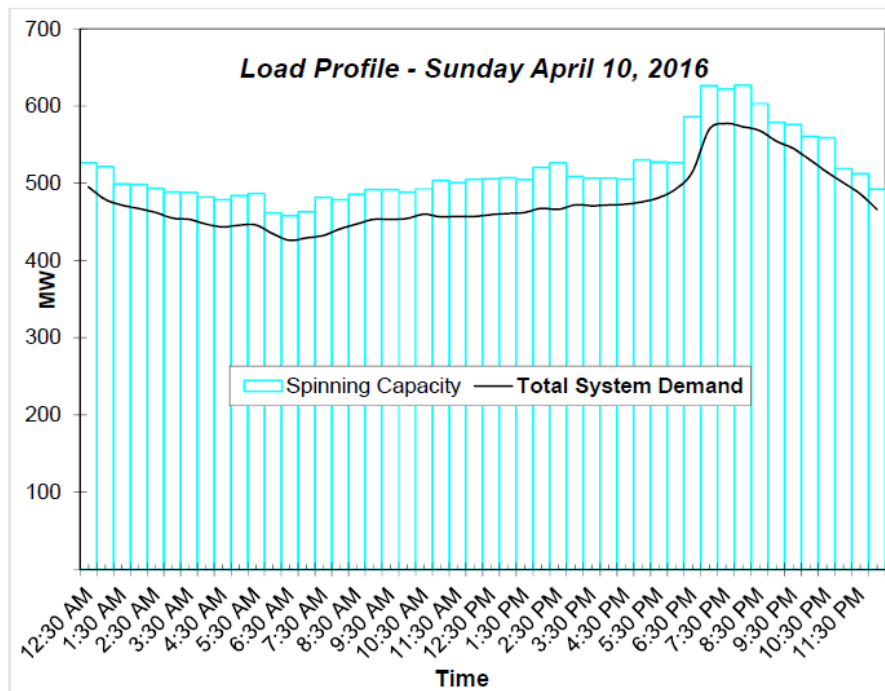
Figure 3: System Load Profile Sunday 2016 April 10

Figure 3 below gives the load profile for the previous Sunday of 2016 April 10. This shows the rapid load changes to be expected between 6:30 pm and 8:00 pm on a typical Sunday. The day of the outage was expected to follow this profile. The Jamaica Manufacturers Association (JMA) exhibition at the National Arena was not expected to have any impact on the load profile.

These load expectations were typical of the system Sunday demand profile and therefore not unexpected on the day, since there were no adverse weather conditions or any planned extraordinary event(s) which would have caused any meaningful changes to the load profile.

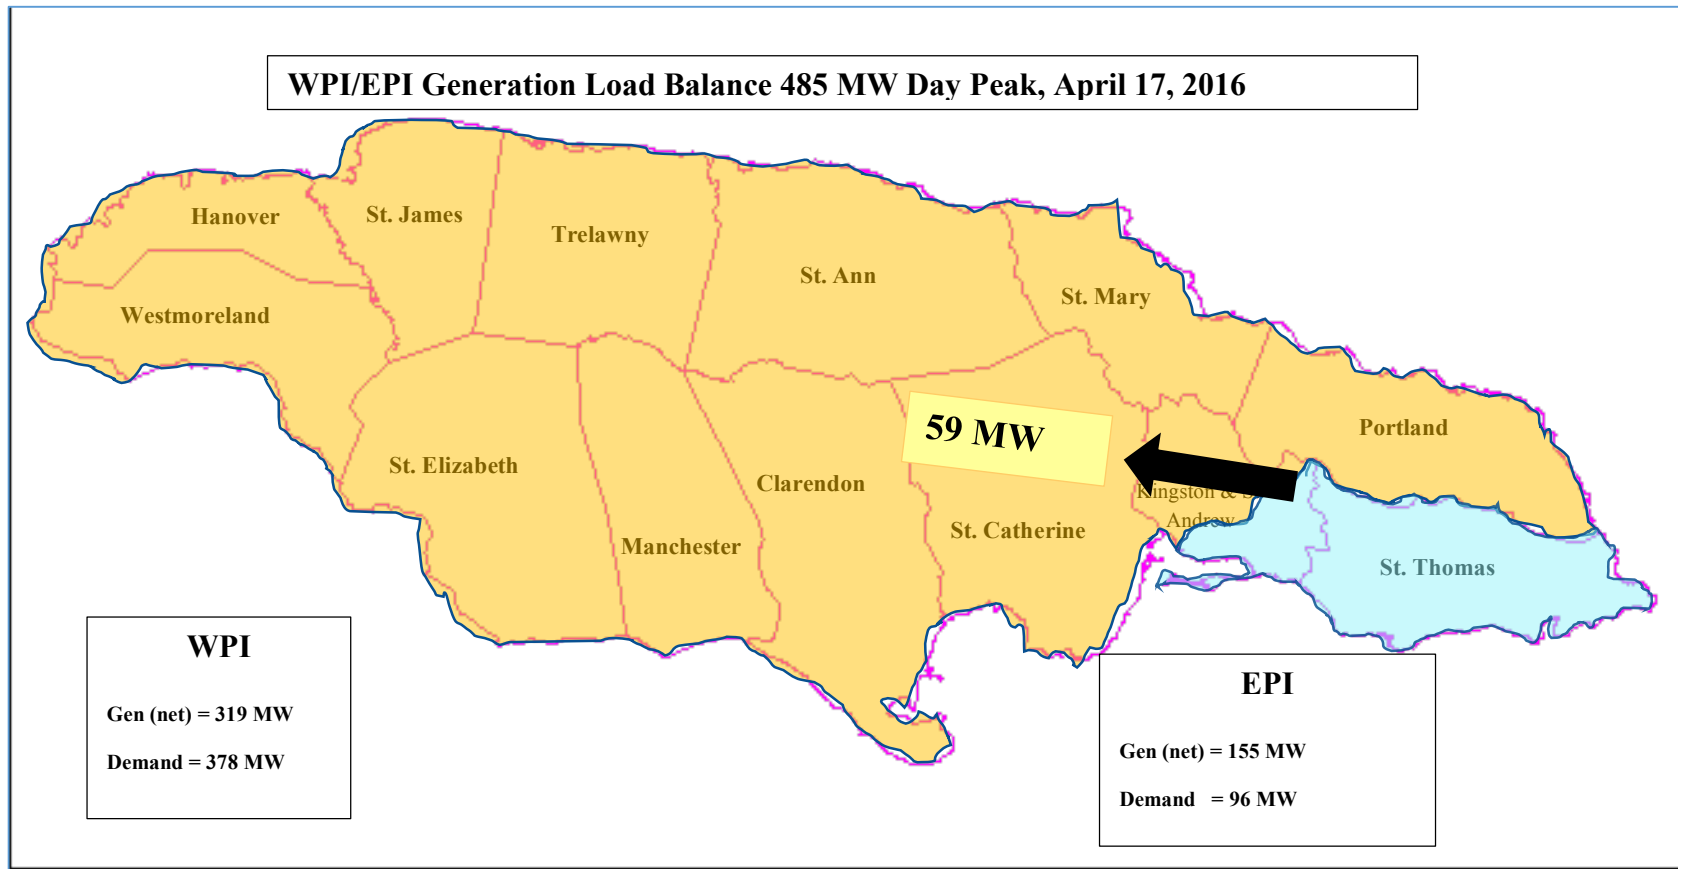
Figure 4: JPS Electrical Sub-systems load balance at 485 MW

, and the system demand and dispatch as shown in Tables 4 and 5 there was a high probability that the system would be unable to meet the demand requirement and planned load shedding would have to be implemented to preserve system security. Given the load–generation balance in the sub-systems, as shown in Figures 4 and 5 approximately 59 MW from the corporate area sub-system would have to be exported to the rural area sub-system via the Duhaney – Washington Blvd 69 kV line for the day peak and 118 MW to meet the evening peak. The system would therefore be at risk of separation during the evening peak given the relatively high load level that would be encountered on this single line connecting the corporate and rural areas. The spinning reserve of 22 MW was inadequate to offer relief to the system in event of sudden reduction in generation and/or sudden load increases. The rural area was severely compromised due to the very uneven distribution of the little available spinning reserve with only 1.75 MW of spinning reserve.

Old Harbour Unit 4 was forced off line the previous day at 4:57 am and was planned for return to service on the 18 April at 10 am. This situation further compromised the system security which should have been evident to the system controllers and the outage planners. This brings to serious question as to the level of coordination between the system controllers and the outage planners and also their level of situational awareness. We would expect that risk assessment should have been carried out to understand the exposure to the system security by going into the outage with this low level of generating plant availability.

It is noted that a relatively large generating capacity was unavailable mainly in the rural areas. At Bogue a number of plants were on long term outages. This situation is reflective of issues in maintaining plant in reliable operating conditions. This in and of itself serves to reduce the ability of the system to respond to contingencies and hence reduce system reliability and security. The system operator has a responsibility to provide reliable service. It is therefore necessary to ensure plants are made available in a timely manner and an appropriate maintenance programme be put in place to improve the availability of the generating plant.

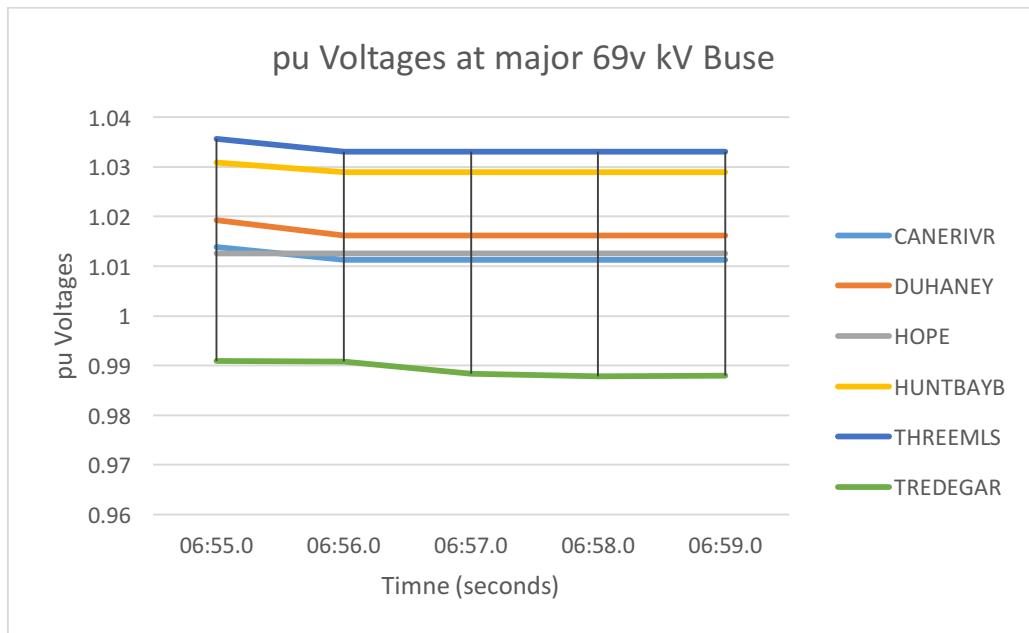
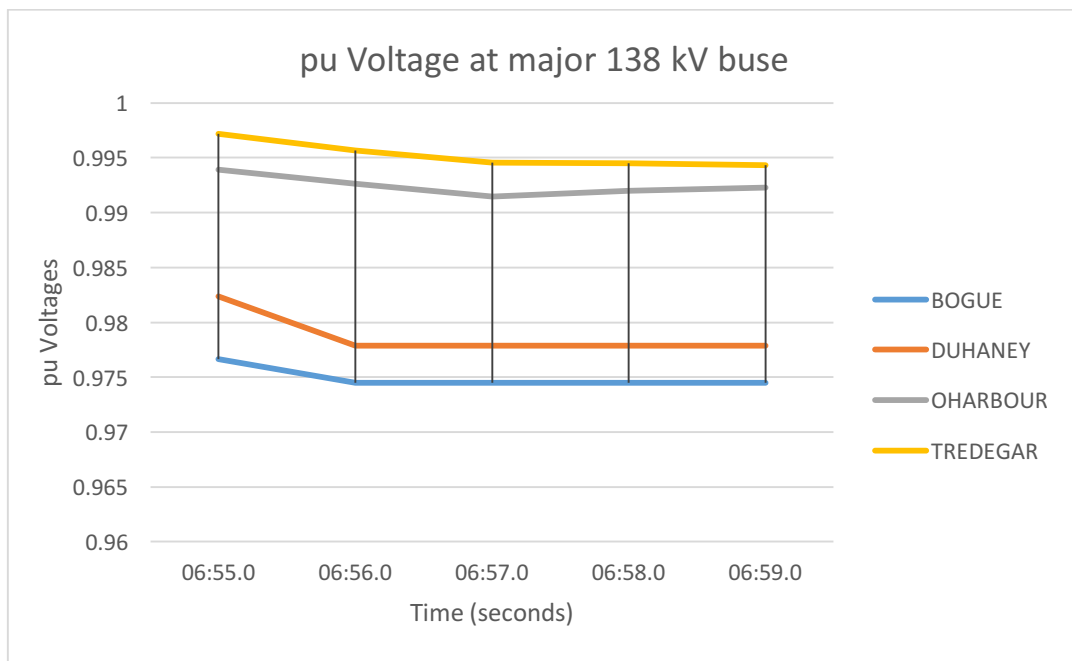
Figure 8: 69 kV substation bus voltage profile on 2016 Aprilat 6:59 pm

Figures 7 to 9 below depict major substations voltage profile and show that the voltages at the main 138 kV and 69 kV buses were well within the operating voltage criteria level prior to the system separation. Bus voltages were within the range of 144.9 -131.1 kV on the 138 kV bus and 72.45 – 65.55 kV on the 69 kV buses ie 0.95 – 1.05 p.u.

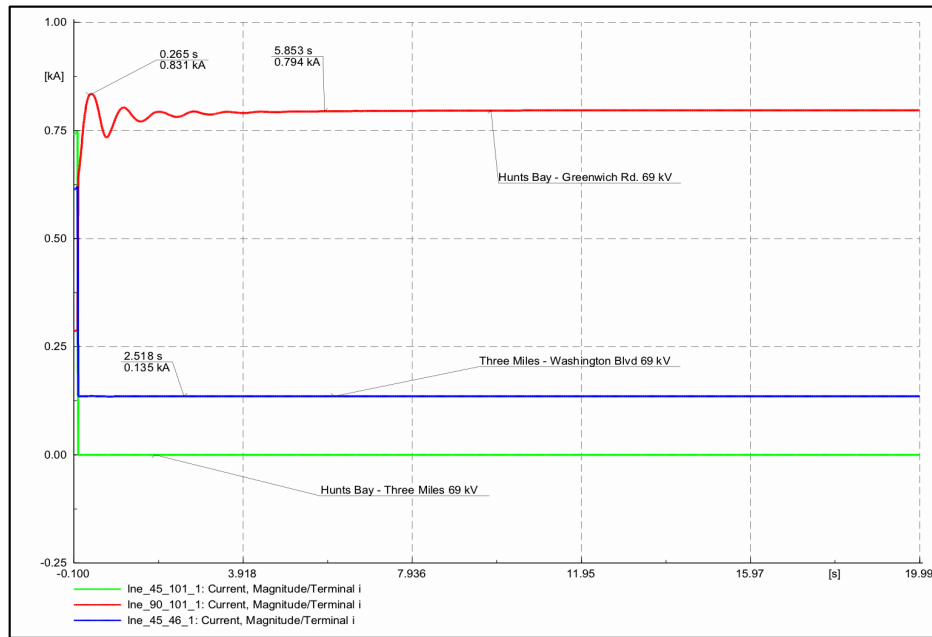
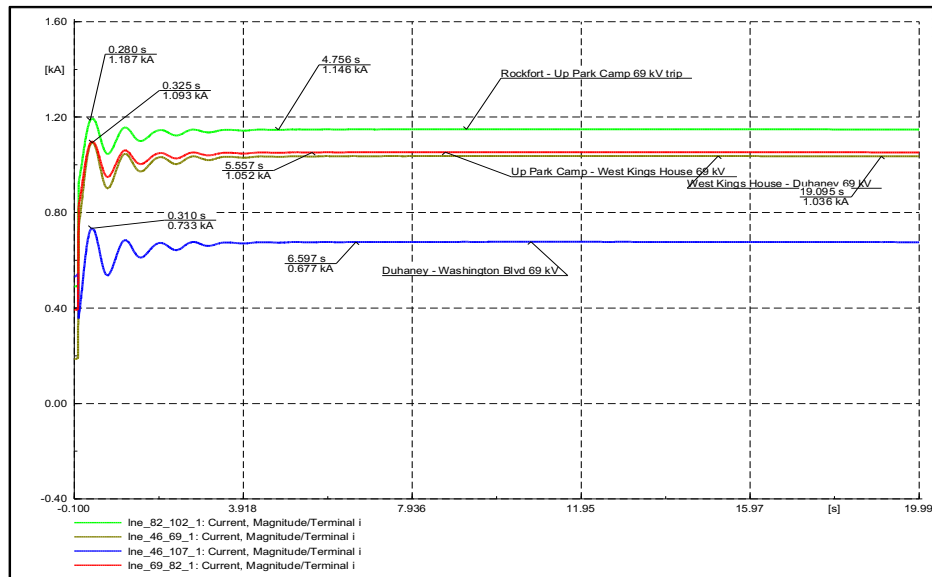
Figure 12: Case 1 - Power flow on major transmission lines in the corporate area

Figure 13–15 below show the current flow and frequency plot prior to the system separation. Upon the loss of the two transmission lines, the Hunts Bay – Three Miles and the West Kings House – Washington Boulevard 69 kV lines, the power grid was divided into two electrical power islands, called the corporate area and rural area subsystems.

Case 1: Hunts Bay – Three Miles 69 kV line tripped

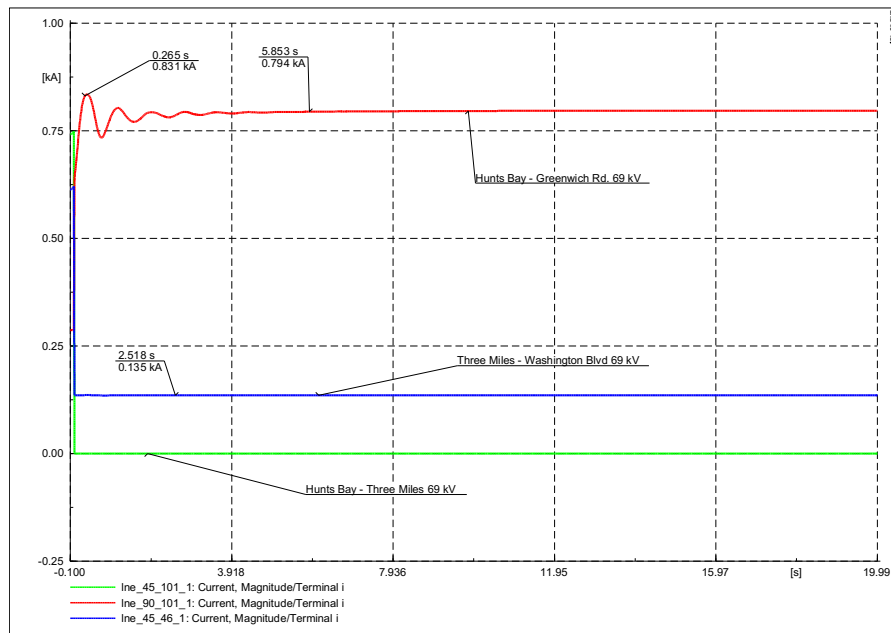
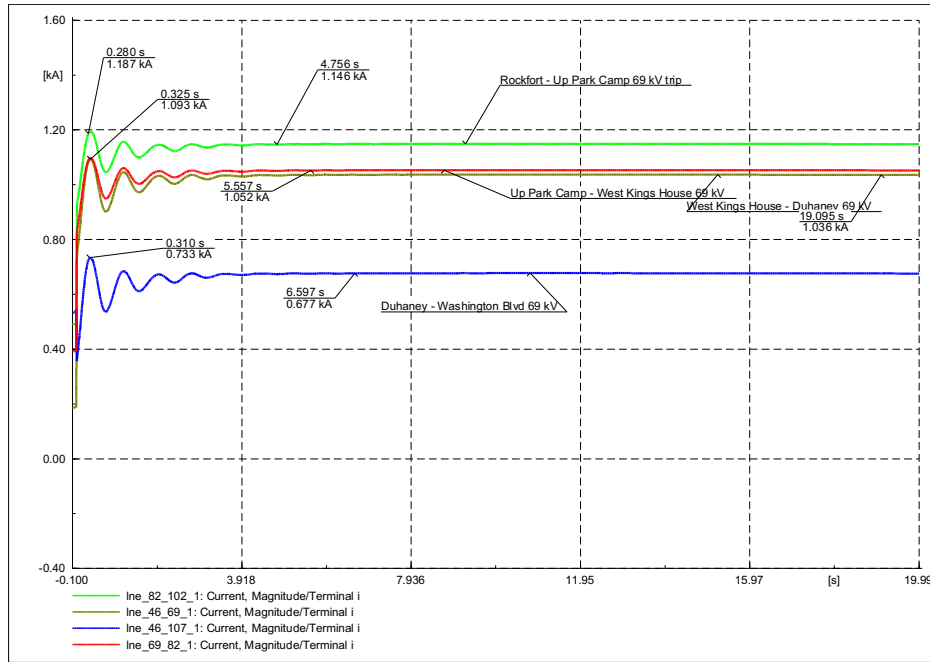
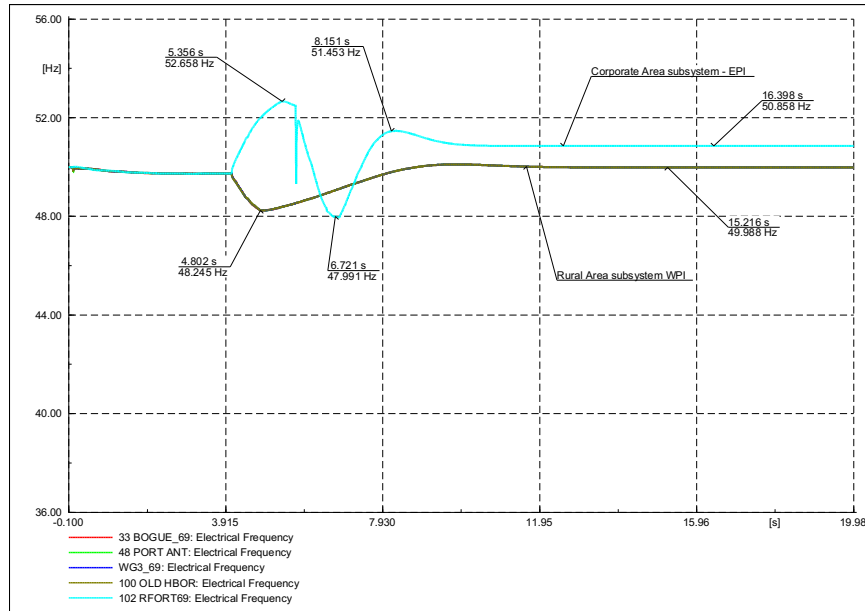
Case 3: Hunts Bay – Three Miles and West Kings House Rd. 69 kV lines tripped.

This case simulated the system conditions similar to April 17th, 2016 at 6:59 pm, with the exception that all of the UFLS points in the rural area system operated.

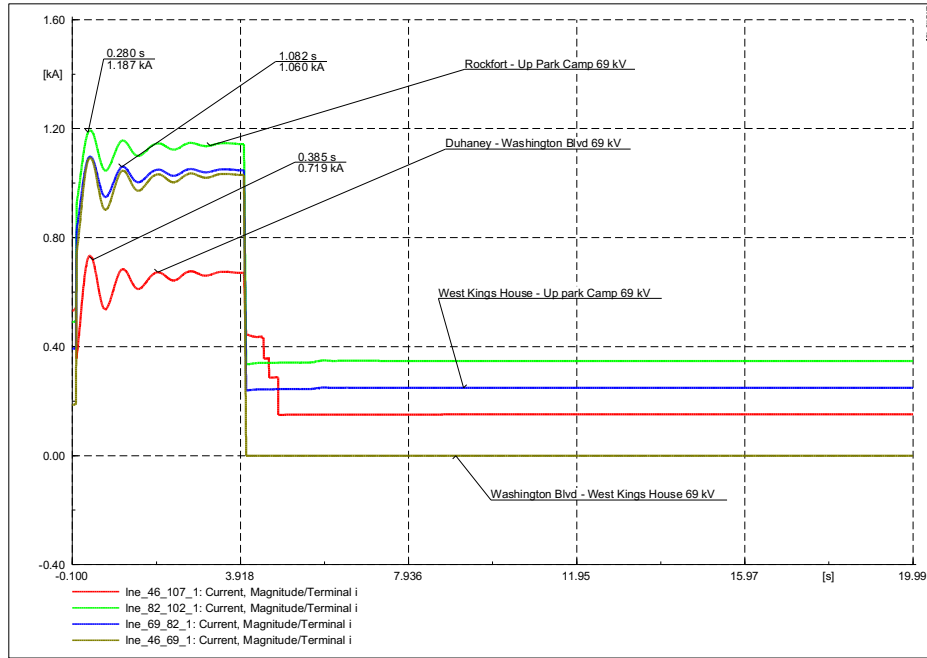
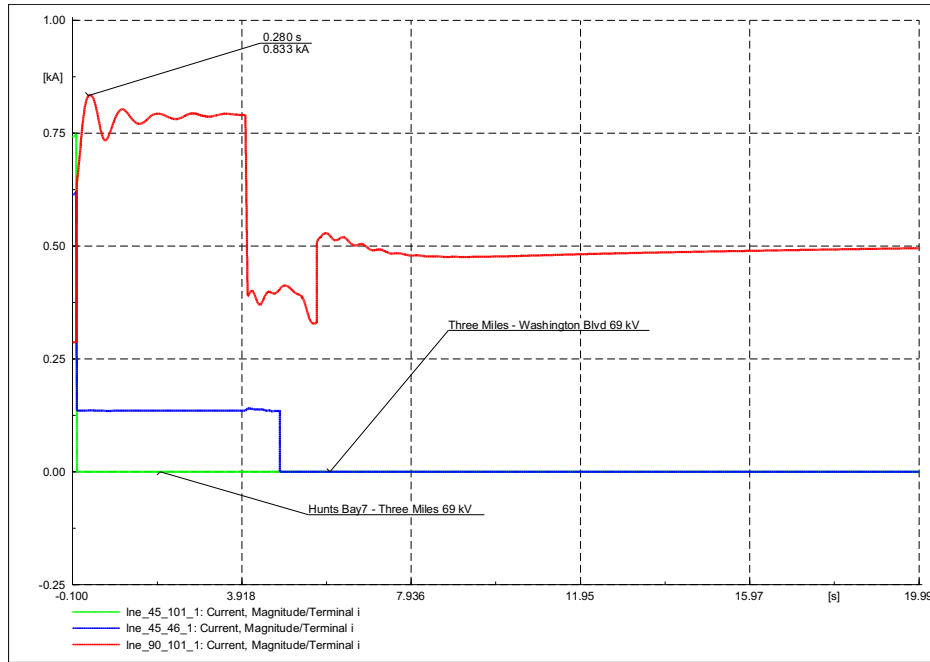
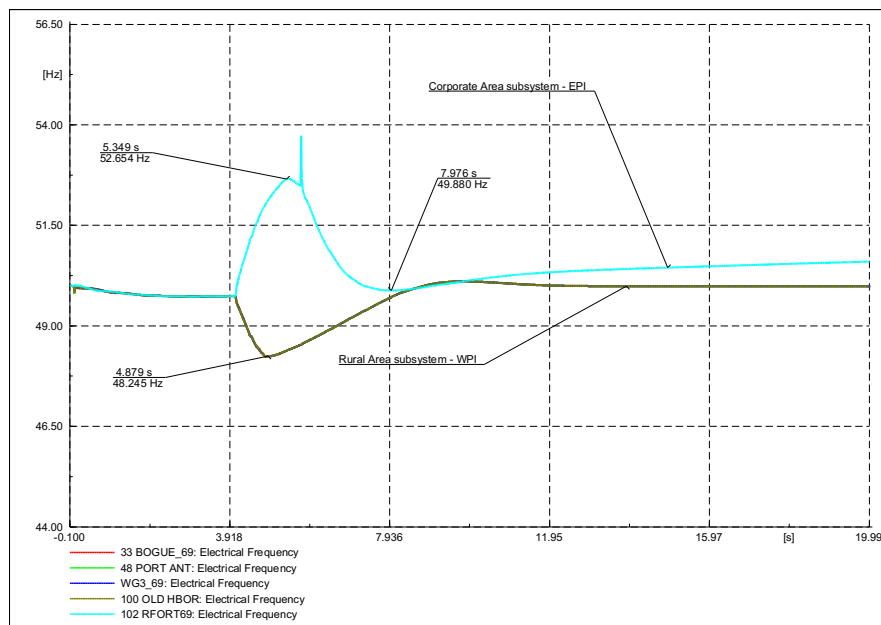
Case 4:

Similar to case 3 with the exception that WKPP 66.3 MW stayed online.

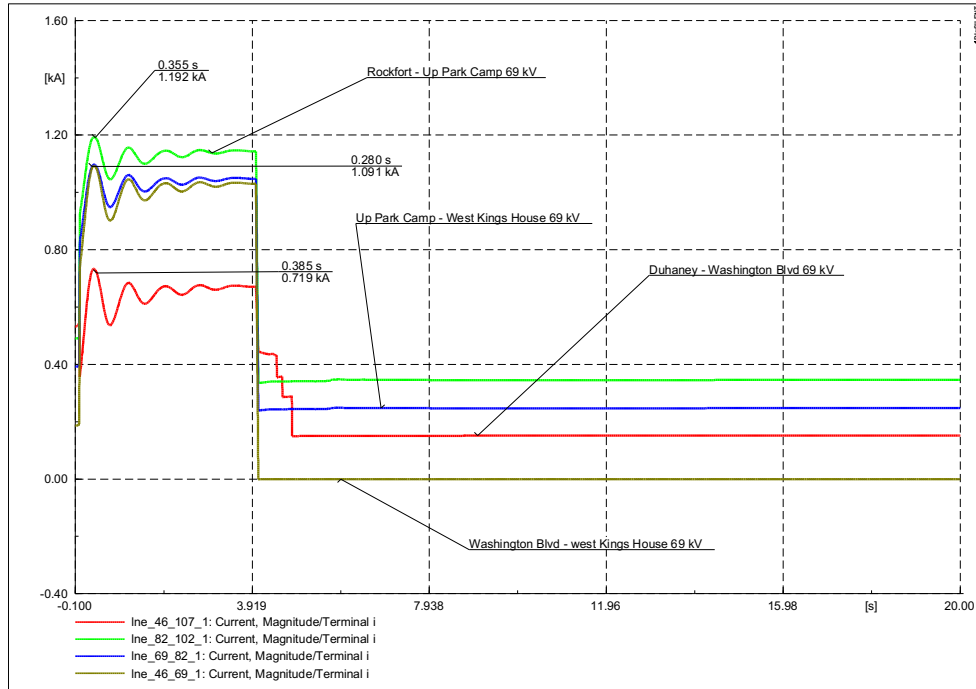
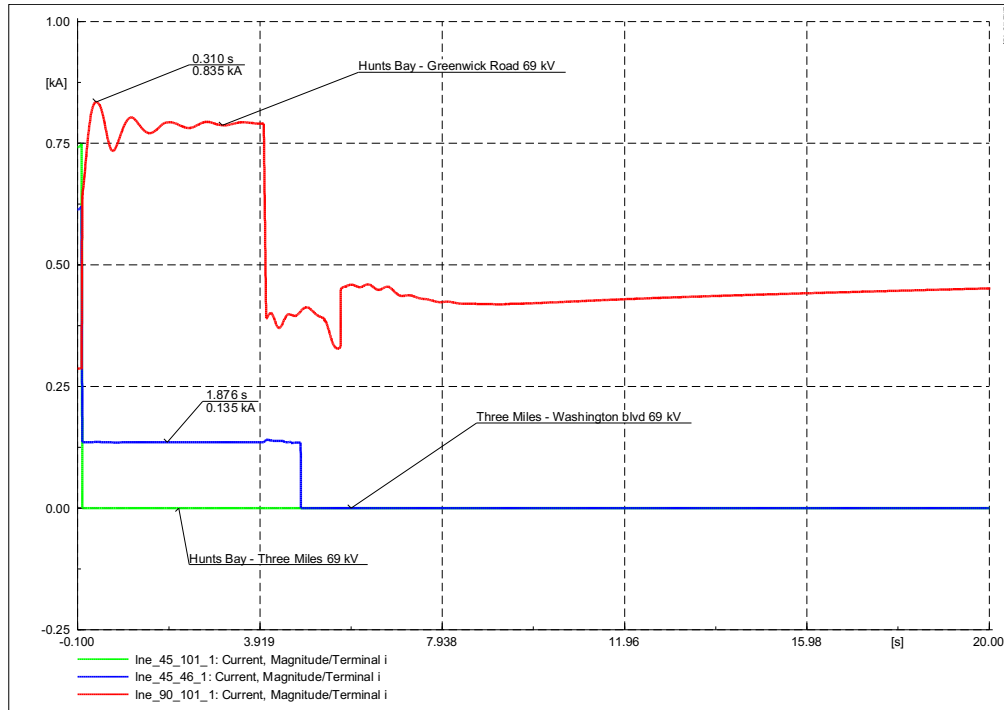
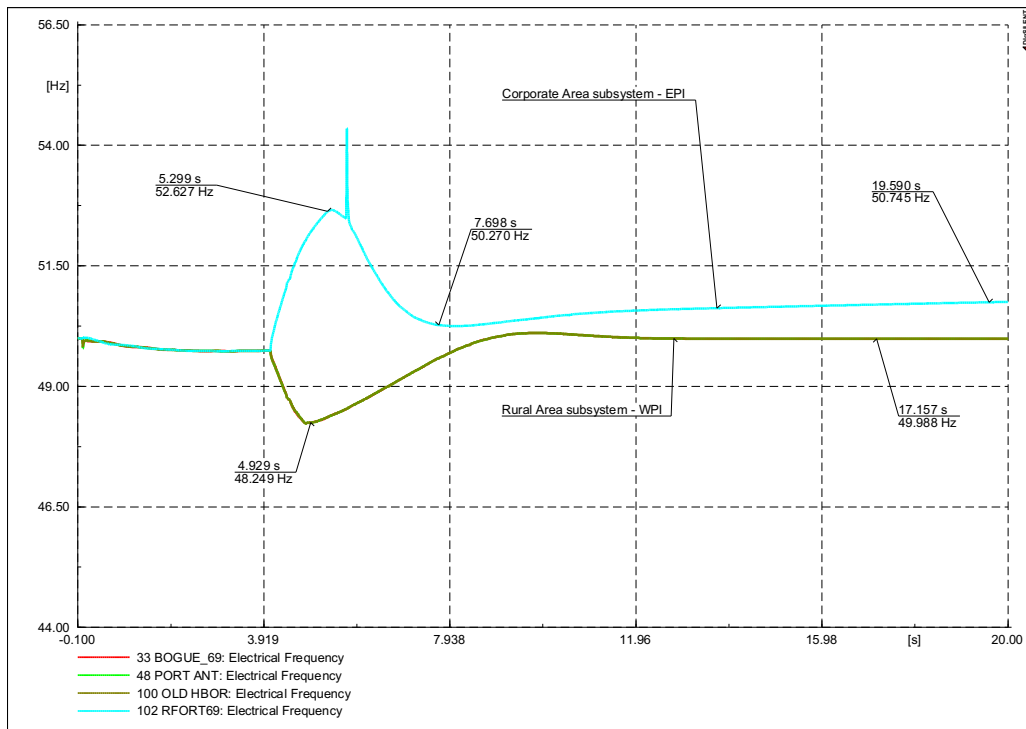
Case 5:

Similar to case 3 with the exception that WKPP and C1, a total of 85 MW stayed online.

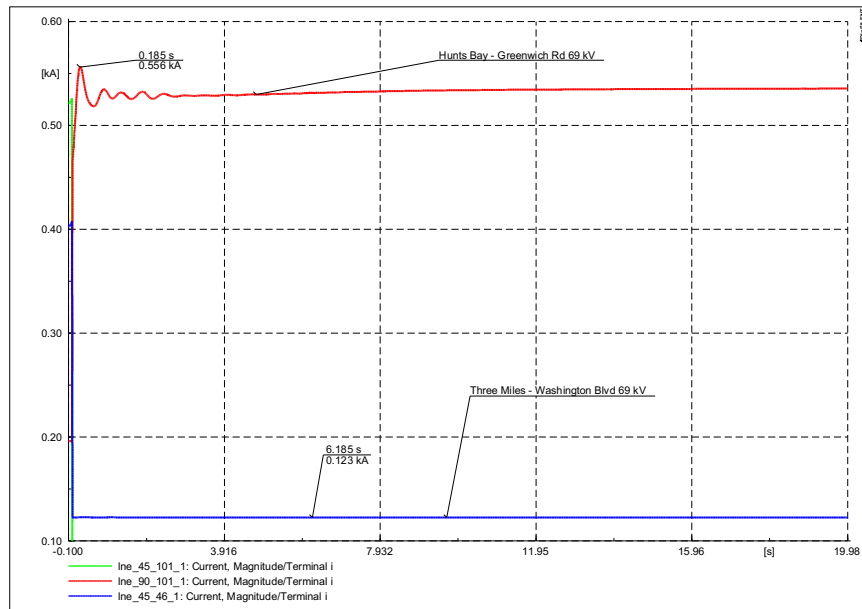
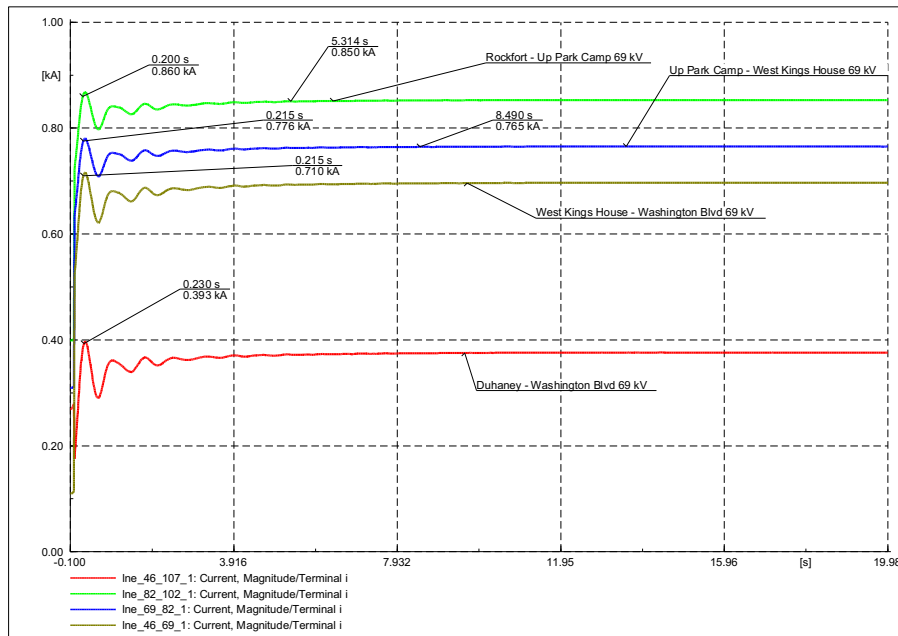
Case 6: 526 MW, Hunts Bay - Three Miles 69 kV tripped

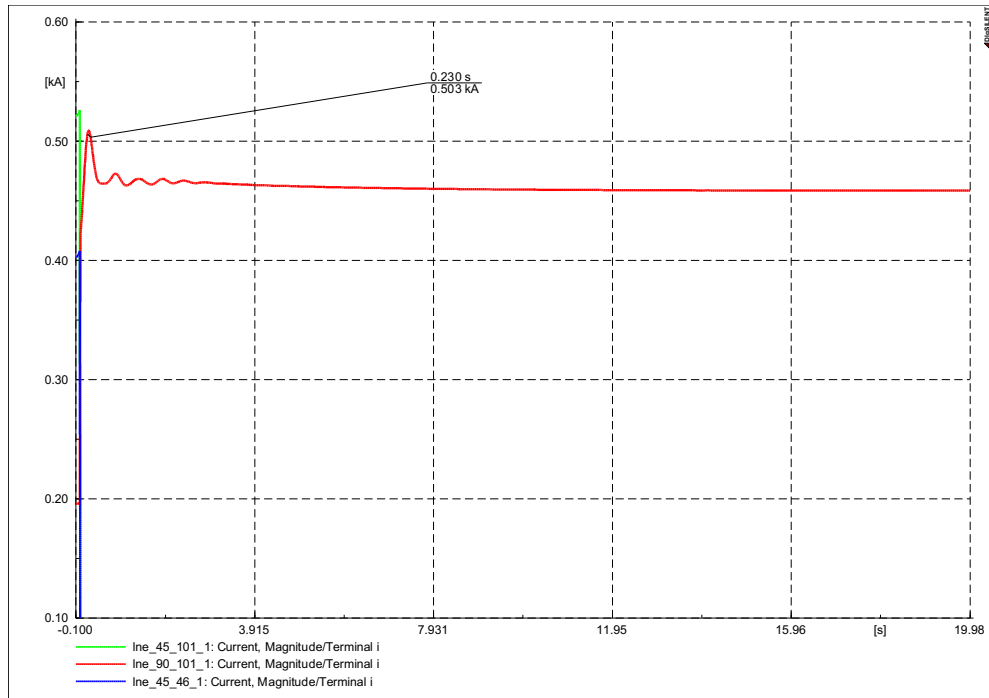
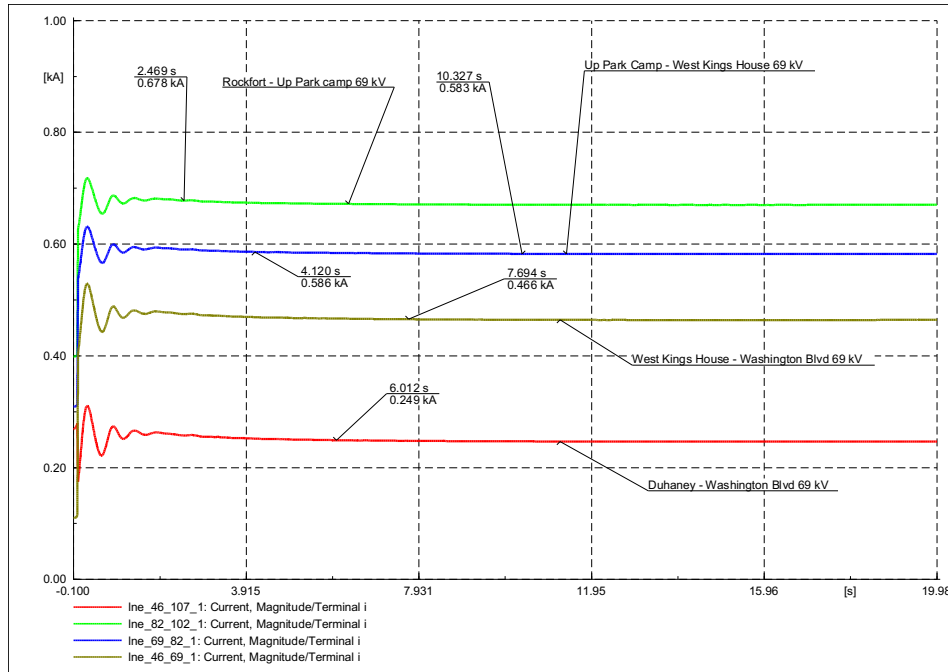
At 526 MW and not running GT #5 and GT #10, the current flow on the Hunts Bay – Three Miles 69 kV line would be 538.5 Amps, as shown in Table 17 above. However, in order to make preparation for the worst case contingency of losing this line, accommodation would have had to be made to shed approximately 70 MW, to prevent the loading on the Rockfort – Up Park Camp 69 kV line from reaching 856 Amps (129.1% loading) and keeping it at 678 Amps (102.3% loading), as is shown in Figures 28-31 below.. However, this shedding of load could not have been manually operated, but would have to be a special protection scheme designed for such or other similar situations.

Case 7:526 MW, Hunts Bay - Three Miles 69 kV tripped. Automatic shedding of 70 MW
