Office of Utilities Regulation

**Enquiry into JPS Power System
Shutdown of July 15, 2006**

Final Report

DOCUMENT NUMBER: Ele 2006/04.1

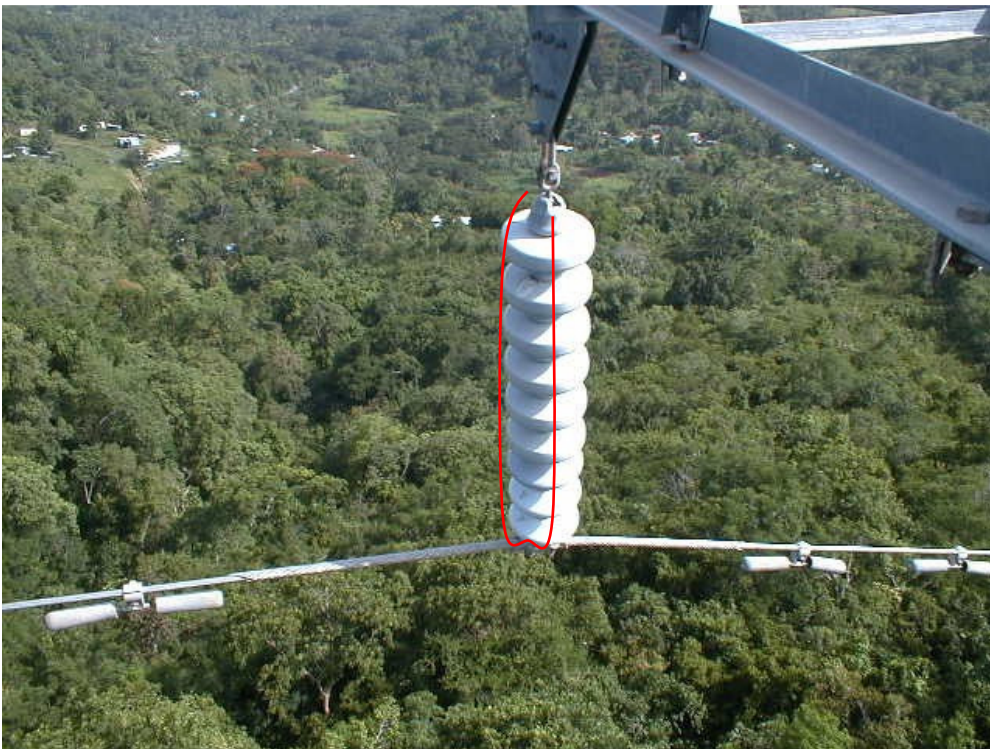
Figure 3: DUNCANS/BOGUE -T75_OUTER PH3_060715

Based on the available evidence namely a) the recording of the fault by the Duncans/Bogue 138 kV transmission line distance relay at Bogue and b) the burn marks on 3 insulator strings at Steel Tower #75 (refer APPENDIX 3), it is concluded that the initiating cause of the incident was a lightning strike to the line or tower on the Duncan/Bogue 138 kV transmission line, resulting in a three-phase ground fault.
